INDOOR AIR ENVIRONMENTAL ASSESSMENT

WAPASU CREEK WEST

Re: Indoor Environmental Assessment at Wapasu Creek West

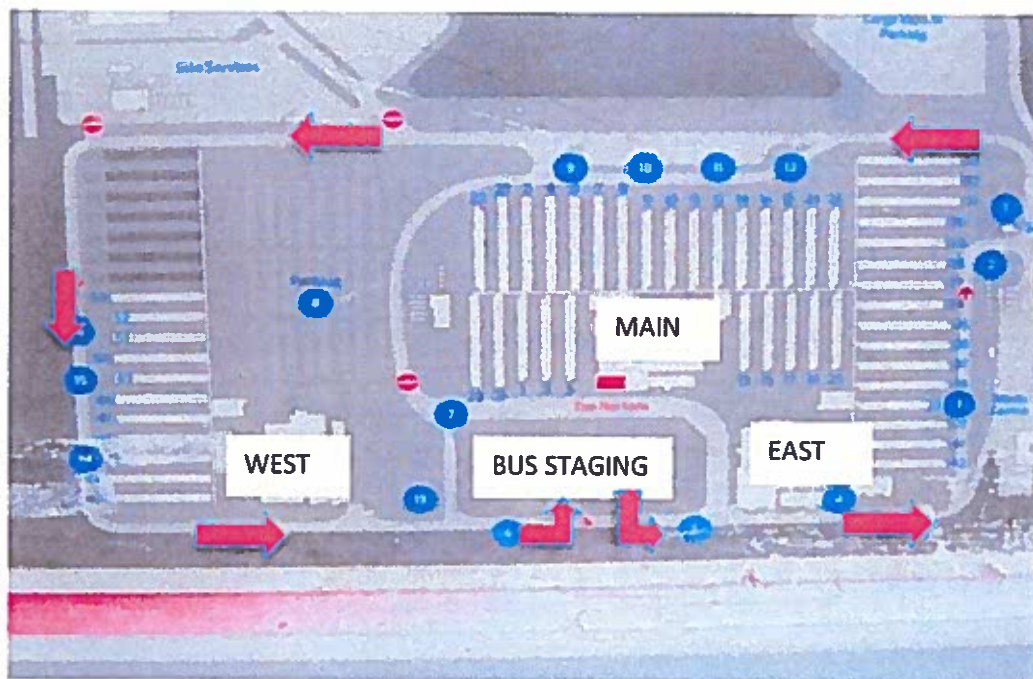
day, buses return to drop off their passengers. The buses run on diesel and because of the large number of buses the potential for compromising the outdoor air quality on busy cold winter mornings is high. For several hours every morning, buses are idling near the air intakes of the kitchen at Wapasu Creek West and Wapasu Creek East. Kitchen staff complain of dizziness, headaches and nausea especially in the mornings. Wapasu Creek East tends to have more problems with vehicle exhaust from the buses.

Fig. 9: Wapasu Creek West, Main and East showing bus staging area in the centre and bus traffic flow around.

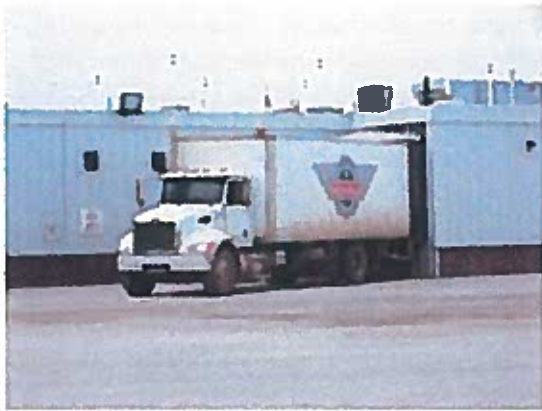
In addition, there are vehicle exhaust fumes from pickup trucks, especially in winter months when the vehicles are parked in the nearby parking lot and left to run all night or are parked for short periods of time while people come in to the Tim Horton's at Wapasu Creek Main. Vehicle exhaust from delivery trucks parked at the kitchen and laundry loading docks is also a concern due to their close proximity to the building's air intakes (figure 10).

Fig. 10: Delivery truck at kitchen loading dock with kitchen air intakes above.

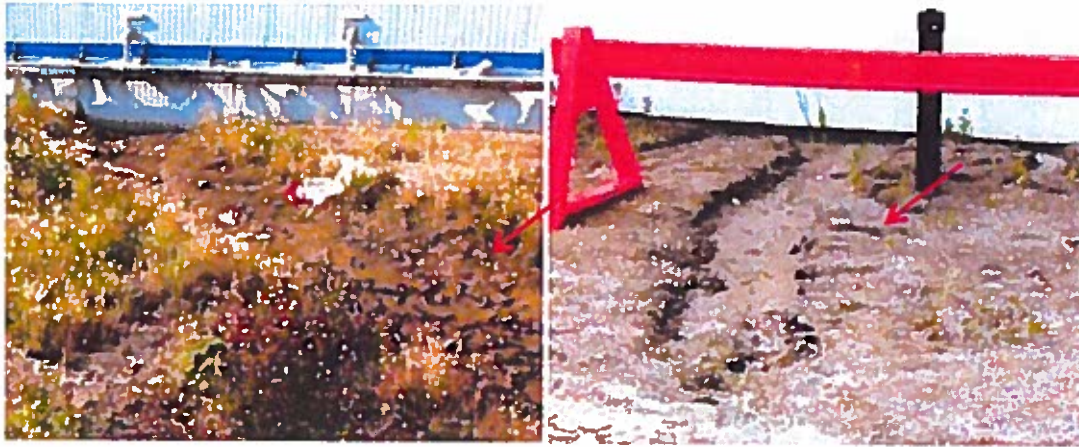
During our site examinations in August 2014 and March 2015, we noted that there are several locations where surface water is migrating into the crawl space (figures 11, 12 and 13). The channels in the ground in figure 12 are caused by water erosion as surface water runoff flows under the building. Some of the courtyard spaces between the wings are saturated with water causing mud to accumulate and the ponding of surface water to occur (figures 14 and 15). Attempted water management techniques

Figs. 11 & 12: Water migrating into the crawl space causes this ground erosion. Location: Henday.

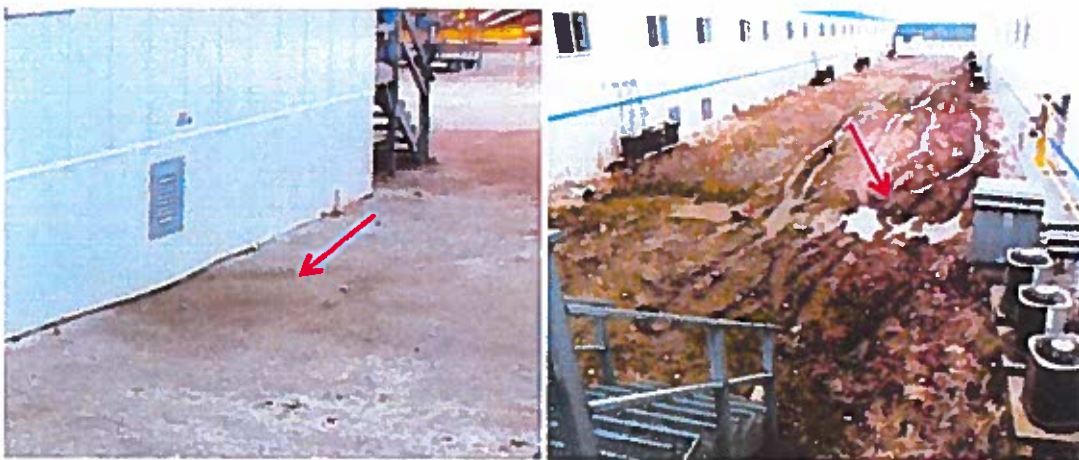
Fig. 13: Evidence of surface water runoff into the crawl space.

Fig. 14: Surface water is not draining away, but it migrating into the adjacent crawl space.

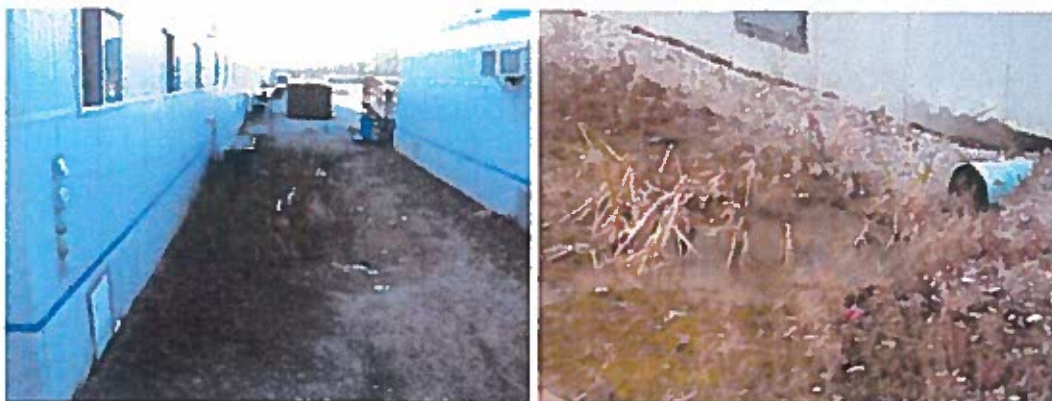
include installing conduits through the crawl space to divert water toward another courtyard (figure 16). The saturated soil underneath the buildings will soften the soil and can undermine the foundation. The moisture can also cause microbial growth that can be drawn into the building from the crawl space through air intakes and penetrations through the floor of the units.

Fig. 15: Water accumulation near the building is a long-term problem as indicated by these cattails growing in a pond between wings at Wapasu Creek East.

Fig. 16: An attempt to manage the water accumulation is by letting surface water flow under the building through a culvert at Athabasca Lodge.

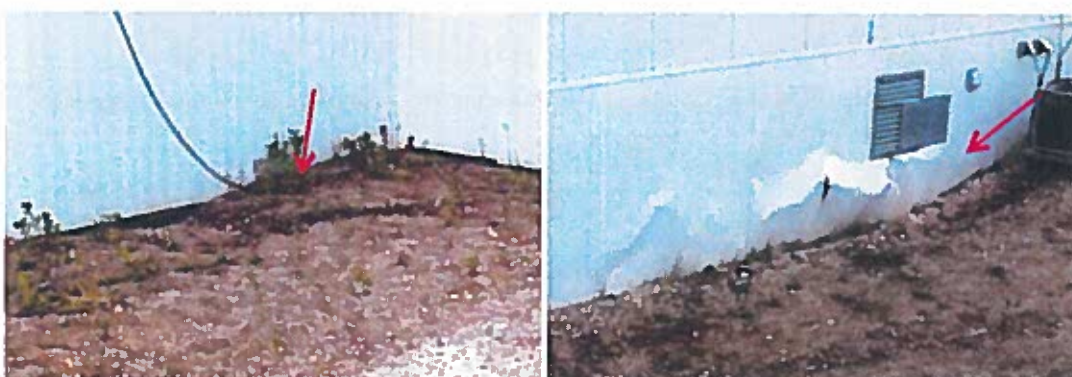
Inadequate skirting provides large gaps that allow rodents and other small animals to enter into the crawl space (figures 17 and 18). Evidence of feces deposits and damage to the insulation is due to these animals inhabiting the crawl spaces.

Figs. 17 & 18: Gaps in the foundation skirt allow animals to enter the crawl space.

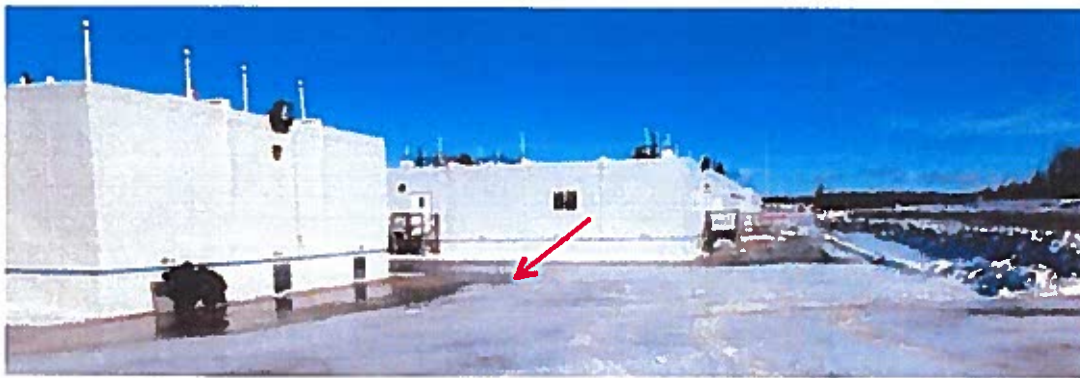
Some crawl spaces are situated in a slight depression, which is lower than the surrounding grade. Furthermore, even when crawl spaces are situated on only a slight rise in grade, surface water can be directed toward the foundation due to ice damming and other impediments to proper dispersal of water. In some cases, water (or ice) accumulates against the foundation skirt (figure 19). It appears that attempts are made to temporarily prevent water from entering into the crawl space by building up snow against the foundation skirt. The snow will inevitably melt and flow into the crawl space. The negative grade slope toward the crawl space is in violation of article 9.14.1.2. of the Alberta Building Code, entitled Crawl Spaces, which states:

Fig. 19: Surface drainage flows toward the building causes flooding the crawl space. Location: Wapasu Creek West.

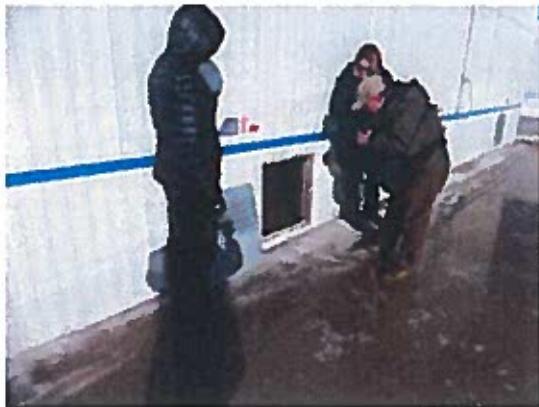
Viewing into the above-grade crawl spaces with some of the ventilation grilles open (figure 20) it is evident that they are flooded with water (figure 21). Furthermore, debris including organic material is left soaking in pools of water (figure 22). Insulation, which was not properly secured, is strewn throughout, perhaps by rodents or other animals that may occupy the crawl space (figure 23). Some of the debris has rotted and deteriorated such that it has become contaminated with mould. Standing water can also be a breeding ground for insects including mosquitoes.

Fig. 20: Opening up some crawl space grilles at Wapasu Creek West to view inside.

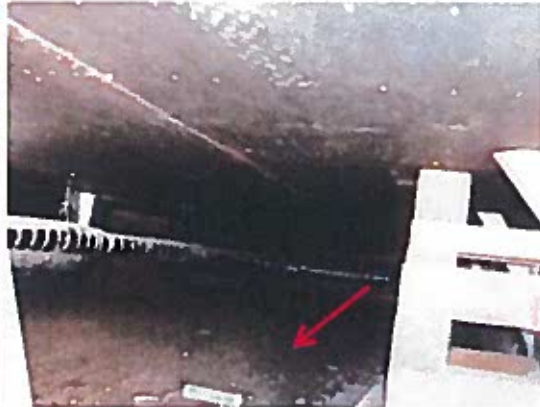
Fig. 21: Mud on the ground inside the crawl space.

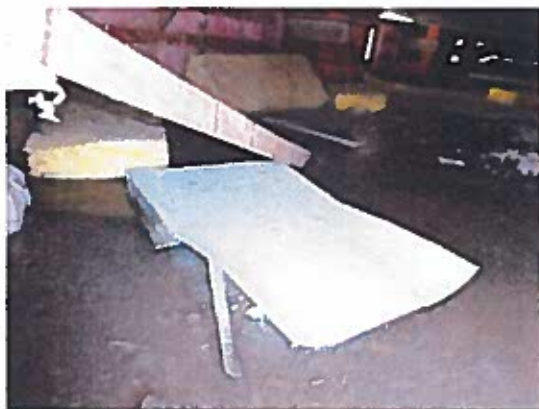
Fig. 22: Debris including insulation and wood are left inside this crawl space.

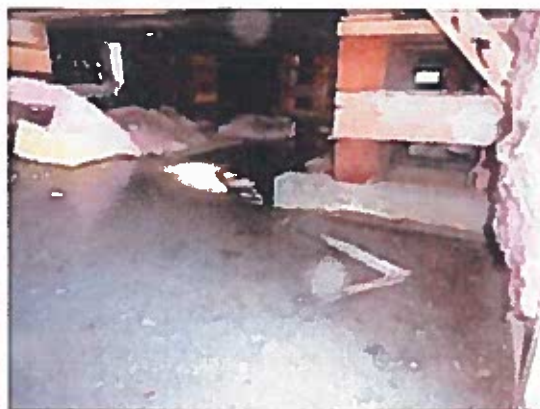
Fig. 23: This crawl space contains about 2" of standing surface water and ice.

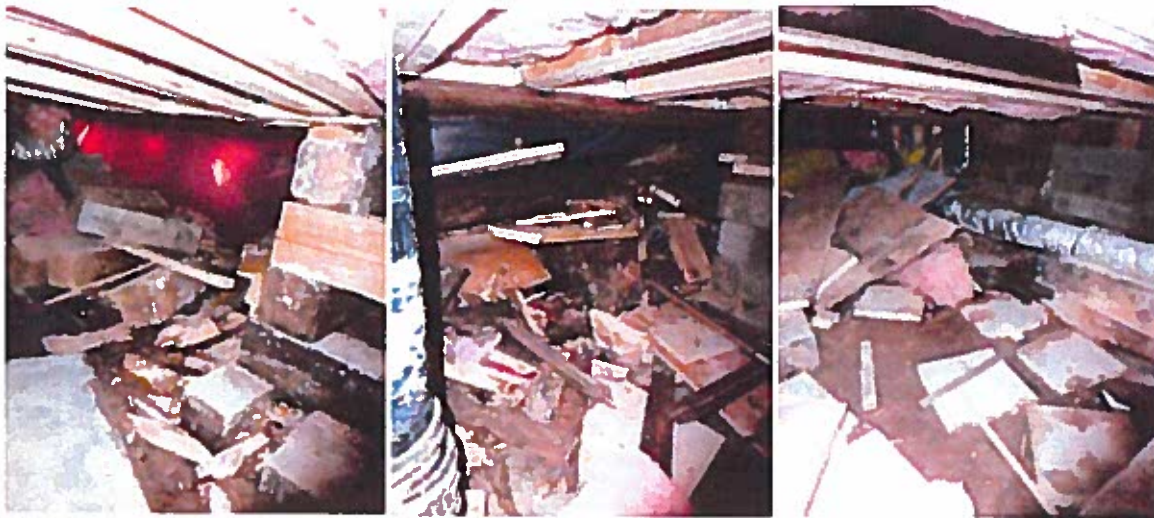
The crawl space under the kitchen at Wapasu Creek East (where mould remediation was in progress) revealed considerably more debris. In addition to insulation, there is discarded wood, paper, gypsum board and other materials throughout the crawl space we examined (figure 24). Of concern is that much of the organic debris is mouldy (figures 25 and 26). Mould spores can migrate up into the occupied areas through penetrations in the floor for ducting, plumbing and electrical services.

Fig. 24: Considerable amount of debris with some quite mouldy.

Fig. 25: Water saturated and mouldy debris in this crawl space.

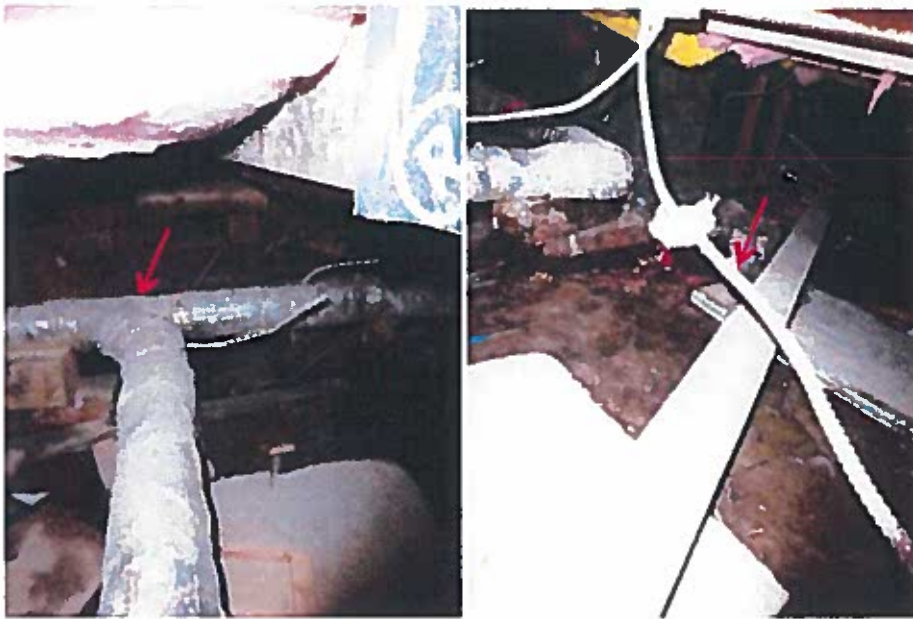
Fig. 27: Ducting is not properly supported by the metal straps.

Fig. 28: Note the dangling conduit and the debris in this crawl space including mouldy wood.

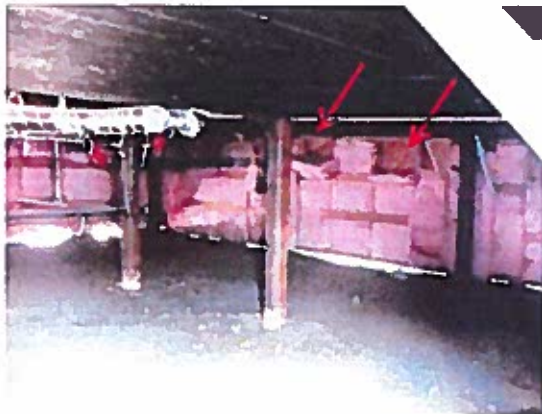
All of the cold crawl spaces at Wapasu are vented with grilles. However, inexplicably, some of the skirting is insulated. The insulation on the skirting wall does not serve any purpose. Only the ceiling of the crawl space must be insulated as is the case in all of the buildings that we examined. Some of the wall insulation has fallen off due to inadequate support (figure 29). Wherever insulation is required, a vapour barrier is needed to prevent condensation in accordance to the building code.

Fig. 29: Insulation falling off the crawl space walls.

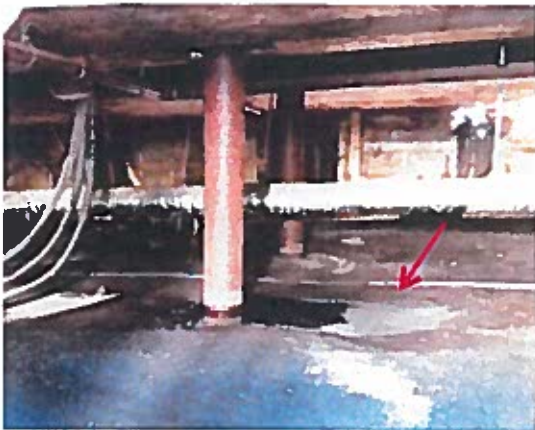
Steel columns are sitting on water puddles in these crawl spaces (figure 30). With freeze-thaw cycles and wet-dry cycles, the column at grade will deteriorate. The water will also compromise the soil bearing capacity underneath these columns resulting in building settlement and leaks.

Fig. 30: Surface water has migrated into this crawl space as seen around the steel columns.

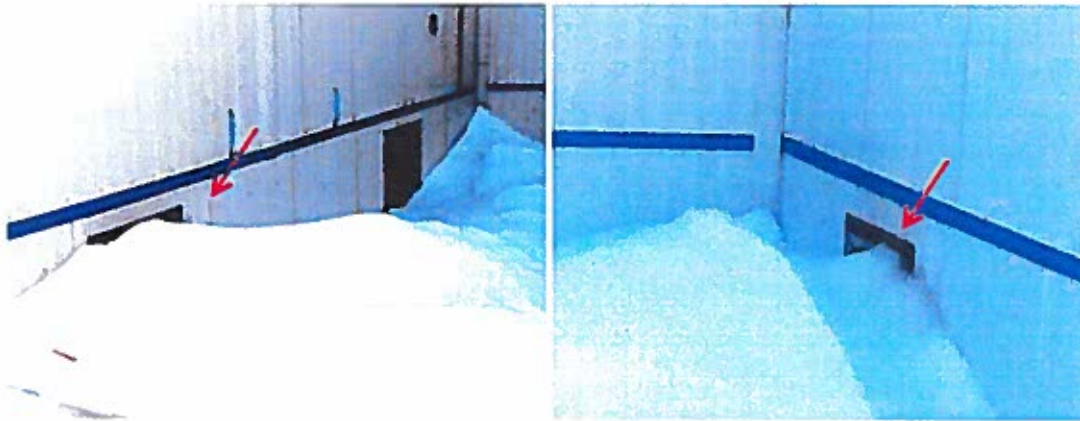
Since these are all vented crawl spaces, the vents must be clear to allow airflow for moisture control. However, some of the vents are covered by snowdrift (figures 31 and 32) or from shovelling snow against the wall. Some of the grilles are partially blocked by snow (figure 33). Since blocked vents do not comply with the ventilation requirements, it is the responsibility of the building owners to ensure that these vents are not blocked. Consequences of blocked crawl space vents include higher humidity and the risk of mould growth. Considering that at the time of our examination spring thaw had melted most of the snow that would typically be in this area, it is likely that several more of these vents are blocked throughout the winter when crawl space ventilation is crucial.

Figs. 31 & 32: Crawl space vents are blocked by snowdrift.

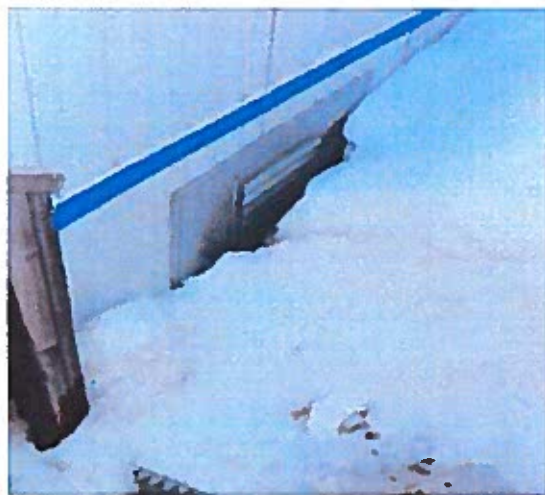
Fig. 33: This air intake grille is partly covered with snow.

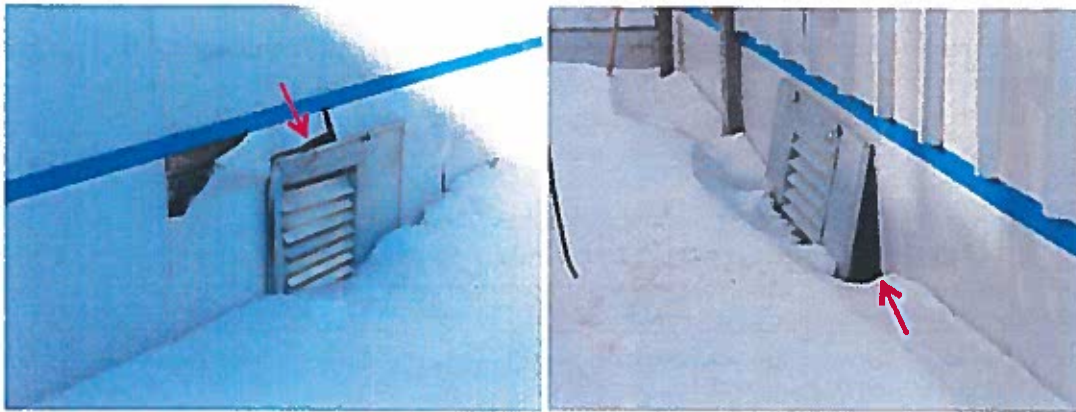
Some of the crawl space vents are damaged (figure 34) and require repair or replacement. The damaged skirting exposes untreated wood materials that are susceptible to moisture damage, especially when rainwater migrating down the wall above is directed behind the damaged skirting. Other ventilation grilles have separated from the skirting (figure 35) and simply need to be re-installed.

Figs. 34 & 35: These crawl space vents are damaged and require servicing.

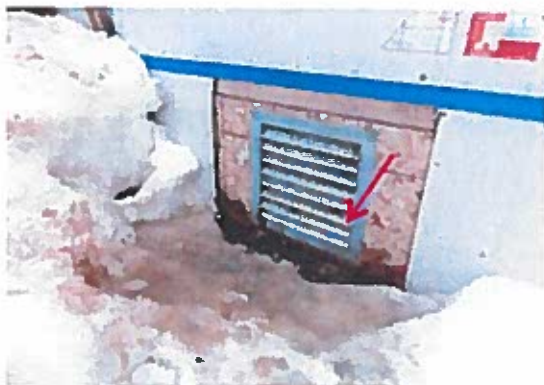
The skirting of these units is installed to prevent animals from nesting inside the crawl space. This skirting must withstand weathering and thus durable weather-resistant materials are used. There are several locations where OSB wood is exposed to the elements. OSB wood cannot withstand weathering for any length of time and therefore should not be exposed (figure 36).

Fig. 36: Exposed OSB wood for the skirting will rot and is not an effective barrier to rodents.

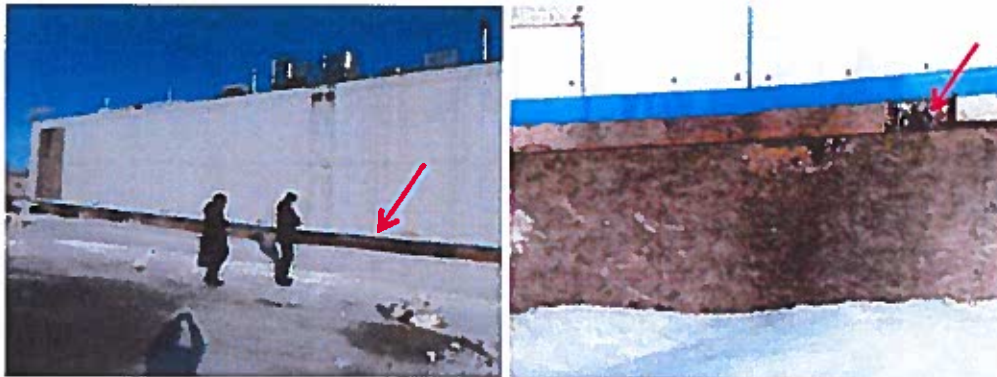
There are several lengths of the skirting around the kitchen (figure 37) and corridors that have exposed and untreated OSB boards. The untreated wood is in direct contact with the ground and snow. The exposed wood is also at the floor header where water has severely rotted the wood framing (figure 38). This deterioration can compromise the structural properties of the wood framing, the insulation and cause mould growth.

Fig. 37: Entire length of this skirting around the kitchen has exposed untreated OSB wood.

Fig. 38: Water has rotted this OSB skirting and wood framing and can support mould growth.

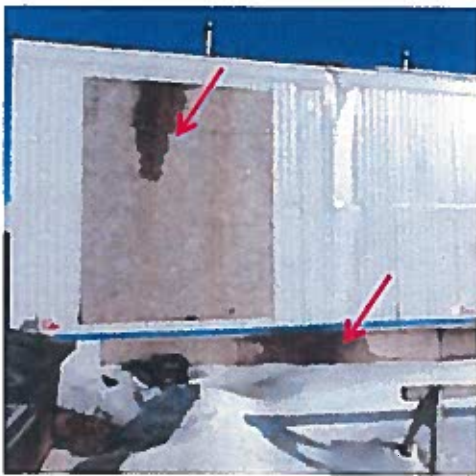
Fig. 39: This OSB is wet and water damaged, allowing water to seep into the wall assembly.

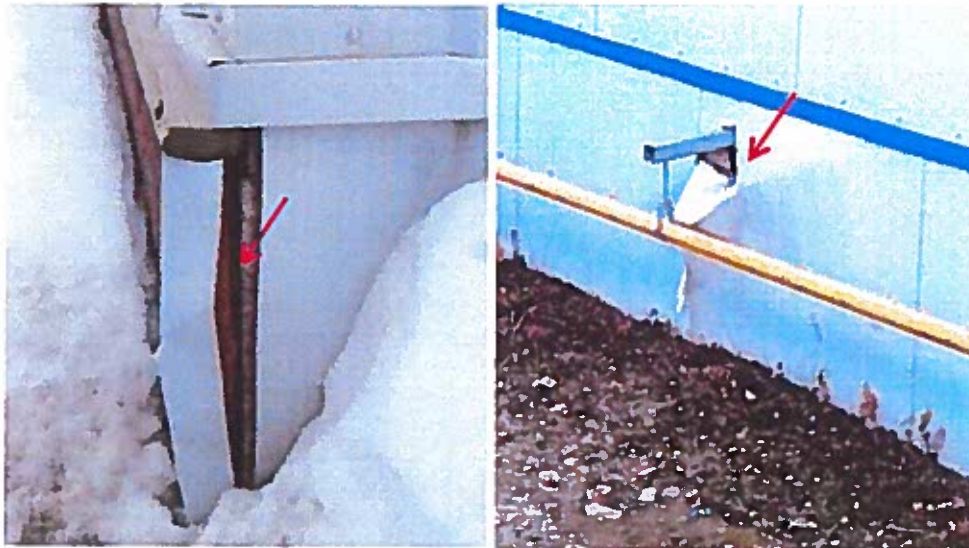
Fig. 40: This damaged corner exposes the wood to weathering.

Fig. 41: Improper pipe support installation exposes the wood to weathering.
