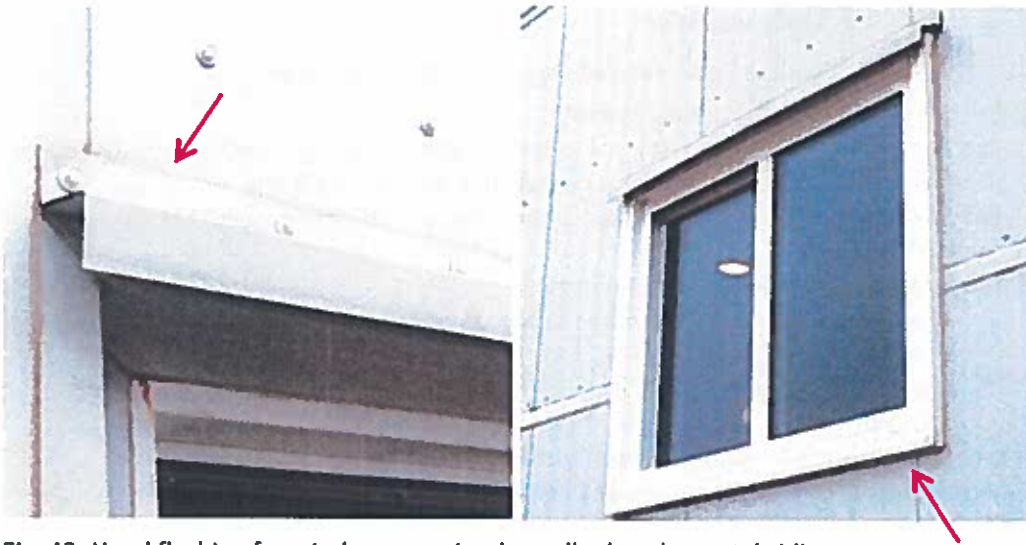
In addition, there is no bottom flashing at the window sills in violation of the Alberta Building Code (figure 43).

Fig. 42: Head flashing for windows are simply caulked to the metal siding.

Fig. 43: There is no sill flashing in this window.

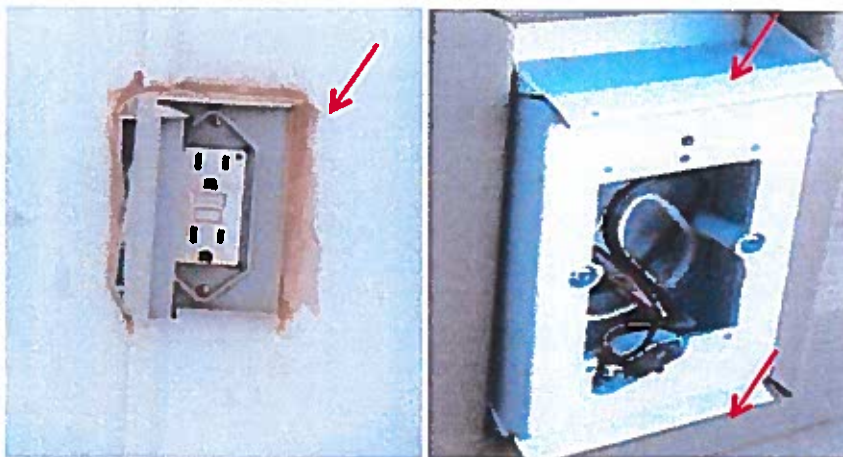
Penetrations such as outdoor electrical receptacles must be sealed to prevent water intrusion. However, the opening for the receptacle is only caulked and the caulking is deteriorating (figure 45). Both head and bottom flashing on the electrical outlet are required (see example in figure 46).

Fig. 45: Caulking cannot reliably prevent water intrusion at electrical outlet.

Fig. 46: Example of proper flashing installation above and below electrical outlet.

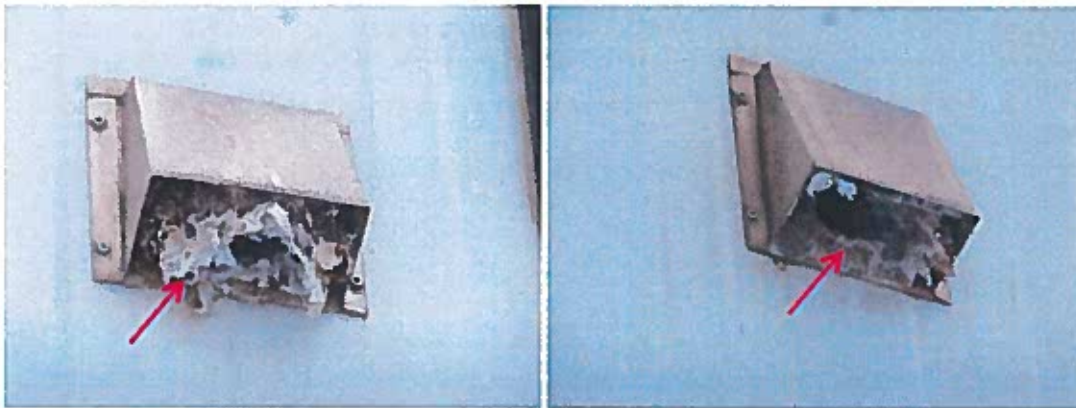
Penetrations such as dryer vent hoods must also be installed with proper flashing. These vent hoods are merely attached to the metal siding and they do not maintain a weather-tight seal (figures 47 and 48).

The accumulation of lint on these dryer vent hoods has constricted effective airflow. Back pressure can force the moist air into the building enclosure to cause interstitial condensation and damage within the wall. Cleaning the vents is part of proper maintenance.

Figs. 47 & 48: Clothes dryer exhaust hood is restricted by lint accumulation.

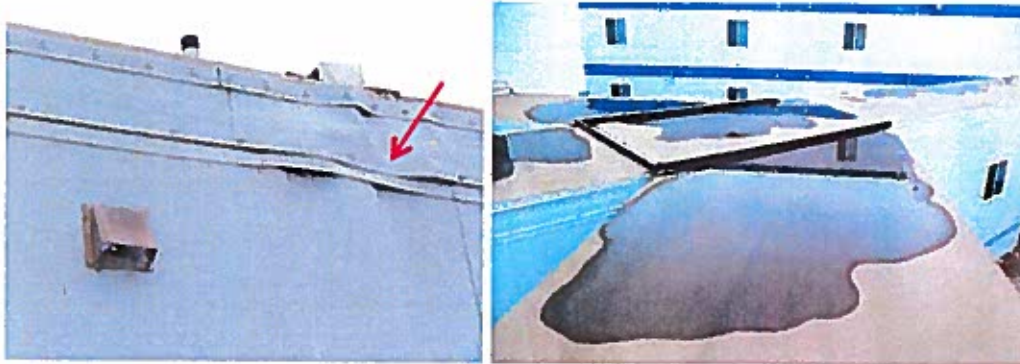
Due to differential movement between modules, the roofing membrane and the metal wall cladding have buckled (figure 49). These locations will tear any seal and waterproofing of the building enclosure. The Alberta Building Code requires that assemblies are watertight. Article 5.6.2.1.(1) of the Alberta Building Code, entitled Sealing and Drainage, states:

Fig. 49: Warping at connection between modules causes ruptures in the roofing membrane and metal siding to allow air and water leaks.

Fig. 50: Standing water on the roof is non-compliant to the Alberta Building Code.

Water penetrations into the building are caused by defects in the design, lack of provision to accommodate building movements, or by improper installation of waterproofing on the roof. Standing water is seen throughout these buildings (figure 50) as shown elsewhere in this report.

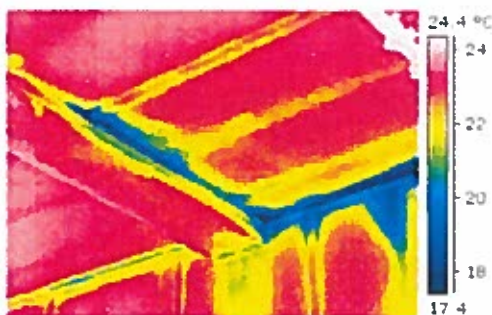
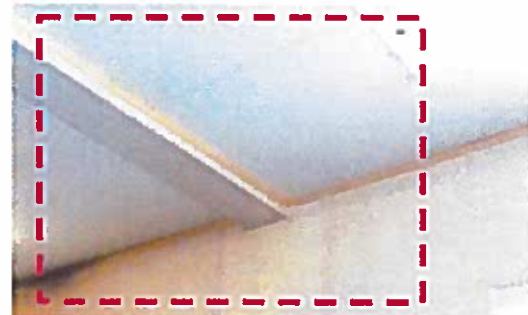
Our thermographic scans also revealed many cold signatures along the junction beams where the modules are spliced together (figures 51 and 52). These cold signatures may indicate the presence of moisture. On the roof, these junctions are difficult to seal properly with roofing membrane. The membranes are often folded and thus gaps are created, which are prone to leaks (figures 53 and 54). A particularly difficult area to create a watertight roofing membrane is at the junctions (figures 55 and 56). Furthermore, differential movements between the modules from thermal expansion and contraction, as well as settlement and wind forces cause shifting at the junction that could tear the roof membrane.

Fig. 51: Cold signatures along the junction beam and the wall-to-ceiling interface in the exercise room.

Fig. 52: Cold signature migrating down this column in the exercise room.

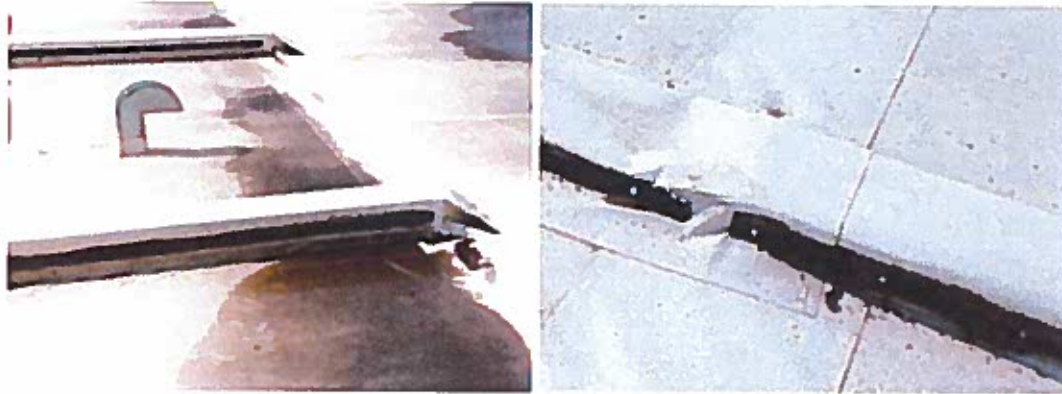
Fig. 53: Junctions between units are difficult to seal properly.

Fig. 54: Defects in the installation of the waterproofing have been patched.

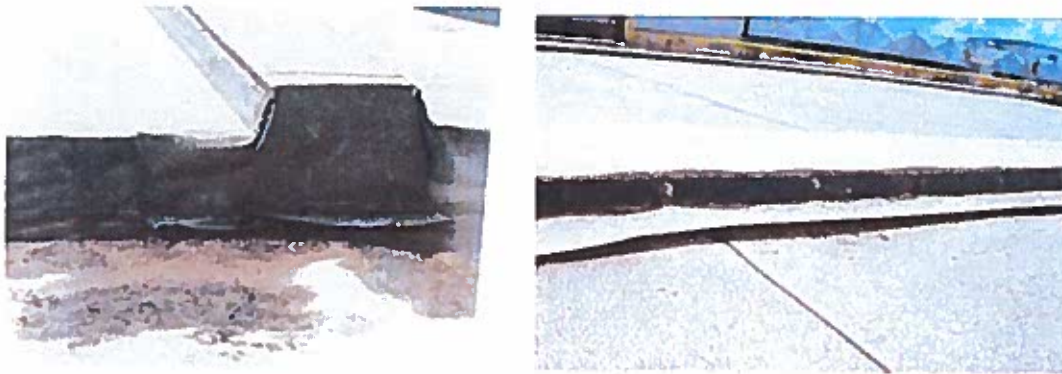
Fig. 55: Folded roofing membrane at this junction is difficult to seal.

Fig. 56: Typical roof membrane junction between units. This detail may potentially cause roof leaks.

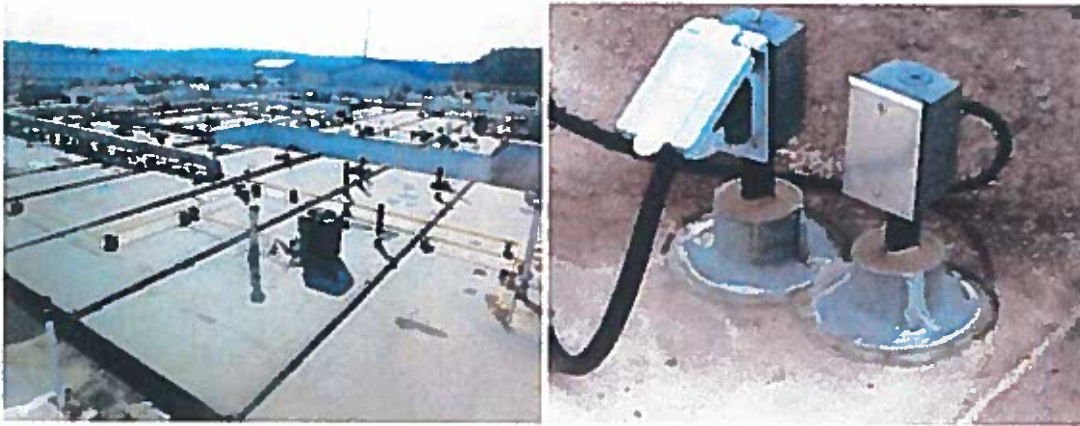
There are many roof penetrations through this waterproofing membrane (figure 57). Many of the roof penetrations for the pipes, wires and ducting rely on some type of sealant or caulking to attempt to maintain the integrity of the waterproofing (figure 58). Article 9.26.4.9. of the Alberta Building Code, entitled Roof Penetrations, states:

Fig. 57: There are many penetrations through the waterproofing membrane.

Fig. 58: Most of the penetrations are simply sealed with caulking.

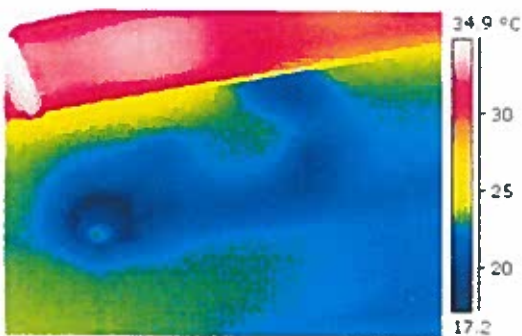
These penetrations may be the cause of cold signatures on the ceiling of the kitchen and other areas (figures 59 and 60).

Fig. 60: More cold signatures on the kitchen ceiling.

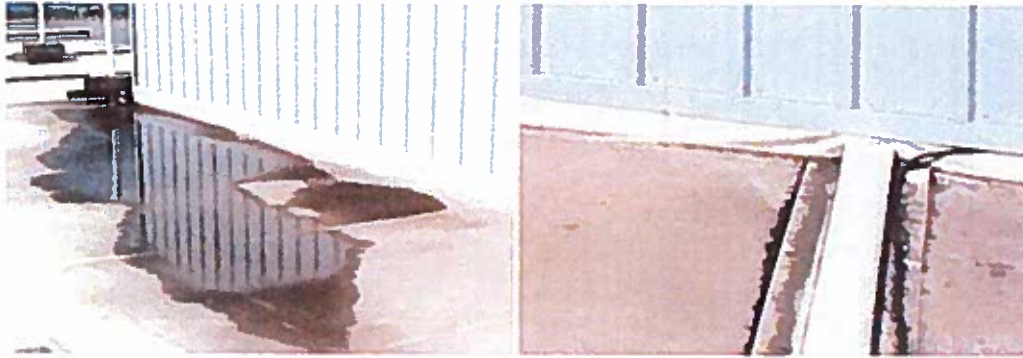
On the roof, water accumulates at the junction between the wall of the raised lobby and the lower roof (figure 61). Wherever two modules are connected together with a raised roof parapet, it is difficult to seal the joint and this can be a source of the water leaks (figure 62). Possible faults in the roofing membrane were observed (figure 63).

Fig. 61: Water accumulation at the junction between the lower roofs and the raised Front Lobby wall.
Fig. 62: Waterproofing this raised parapet junction is difficult.

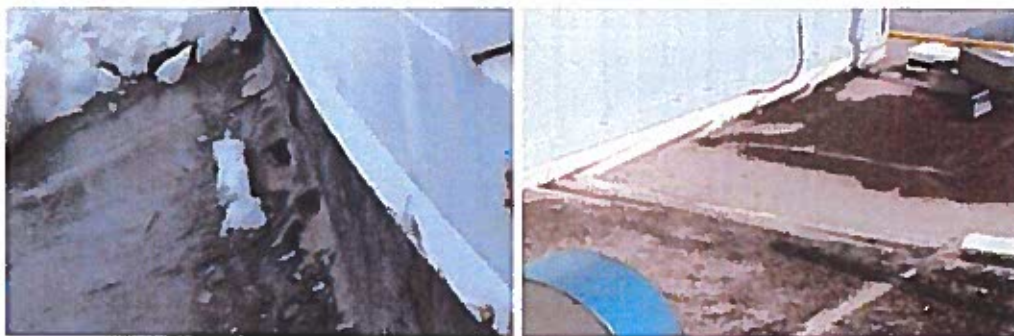
Mud accumulating on the roof is caused by water ponding on the flat surface with no means of drainage (figure 64). Standing water is not permitted as all so-called flat roofs must slope to drain in accordance to the Alberta Building Code.

Fig. 63: Possible faults in the water-proof roofing membrane.
Fig. 64: Soil accumulation is the result of water ponding on the roof.

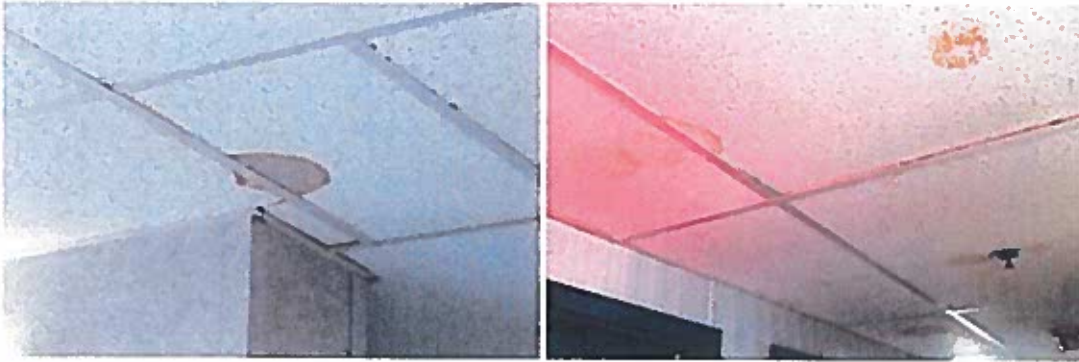
Figs. 65 & 66: Water staining on the ceiling of the corridors.

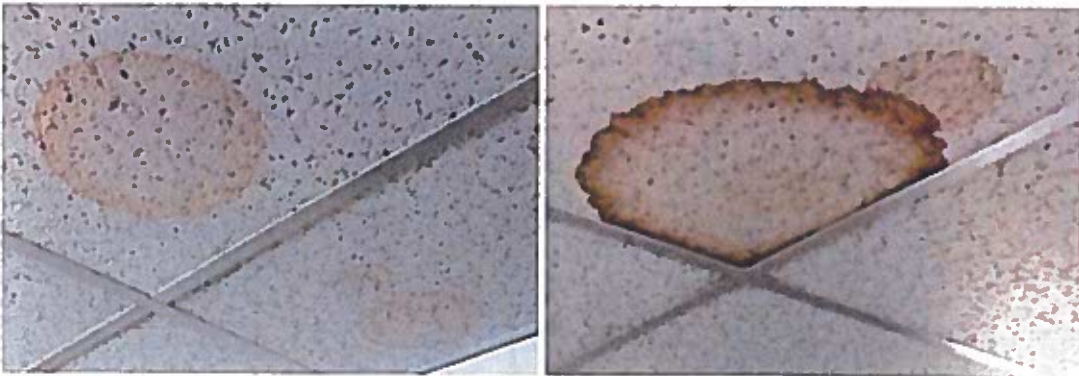
Figs. 67 & 68: Water staining spots on the ceiling.

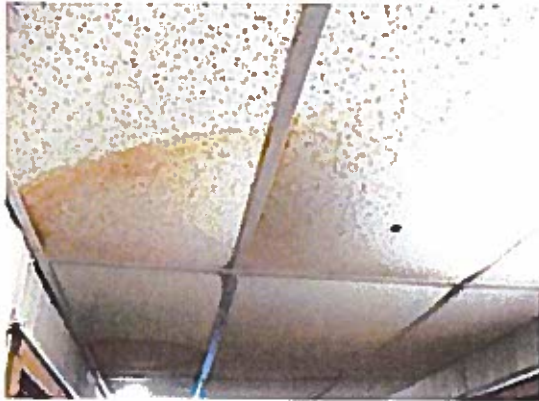
Fig. 69: Considerable water has leaked onto ceiling tiles in this residential corridor.

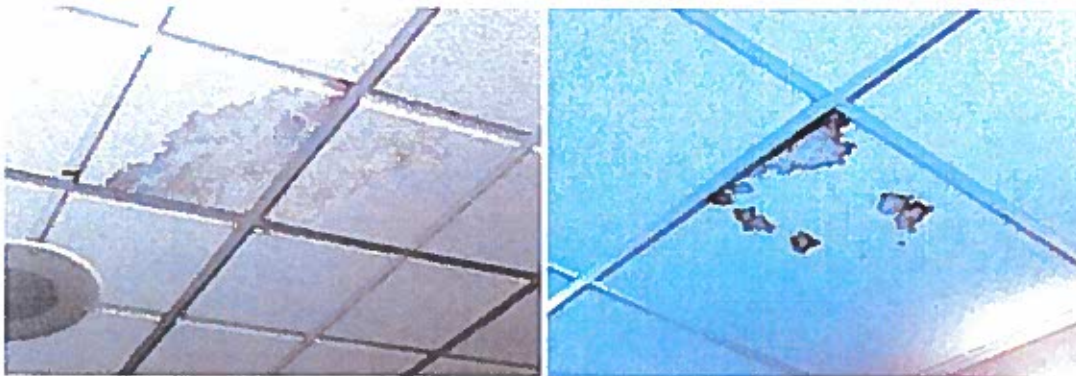
Figs. 70 & 71: Older water stains on the ceiling.

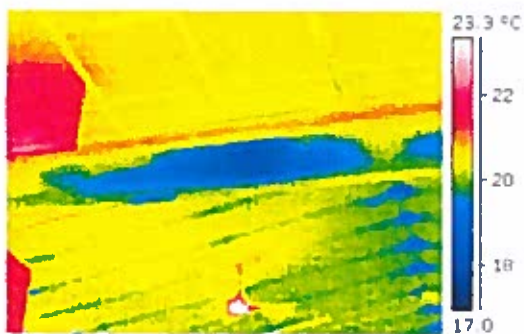
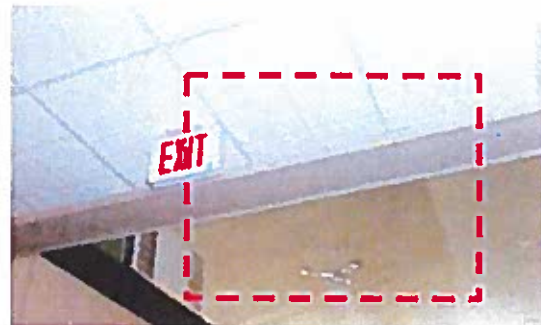
Thermographic scans reveal evidence of moisture in the ceilings of these buildings. Leaks at the junction between the raised roof of the lobby and the lower portion of the building are discernible at the juncture between the front lobby and the main corridor (figures 72 and 73).

Fig. 72: Moisture above this beam in the front lobby.

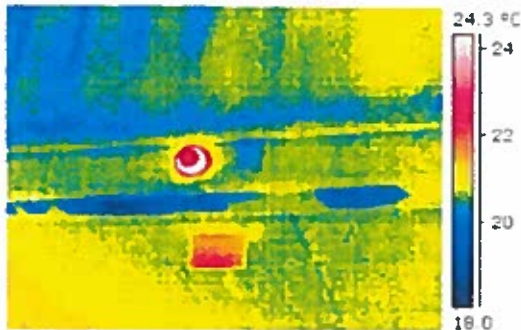
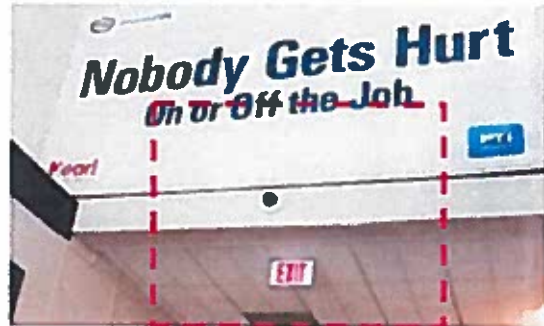
Fig. 73: Moisture along the same beam in the main corridor.

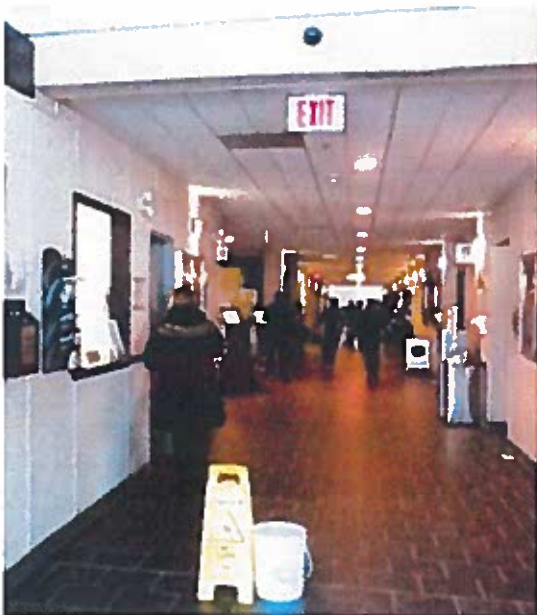
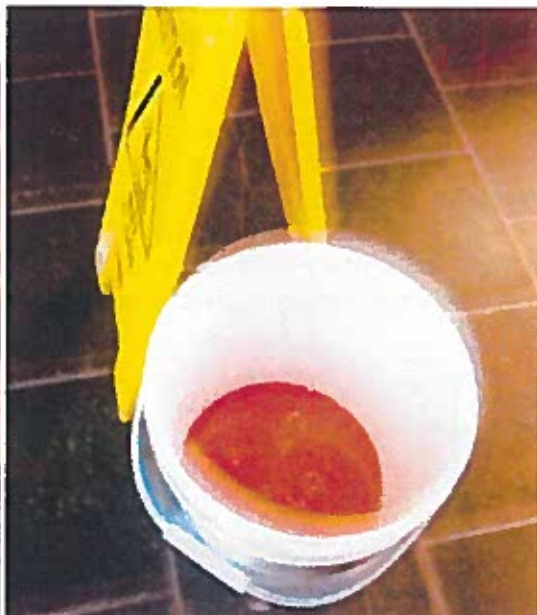
A bucket to catch the water had been placed under the drip and a caution sign was set next to it (figures 74 and 75). A bucket was also required in the front office of the lobby (figure 76). Roof leaks were discovered in additional areas of the corridors and towels were placed there to absorb the water (figure 77).

Fig. 74: Dripping water in the main corridor requires a bucket and caution sign.

Fig. 75: Water accumulating in the bucket.

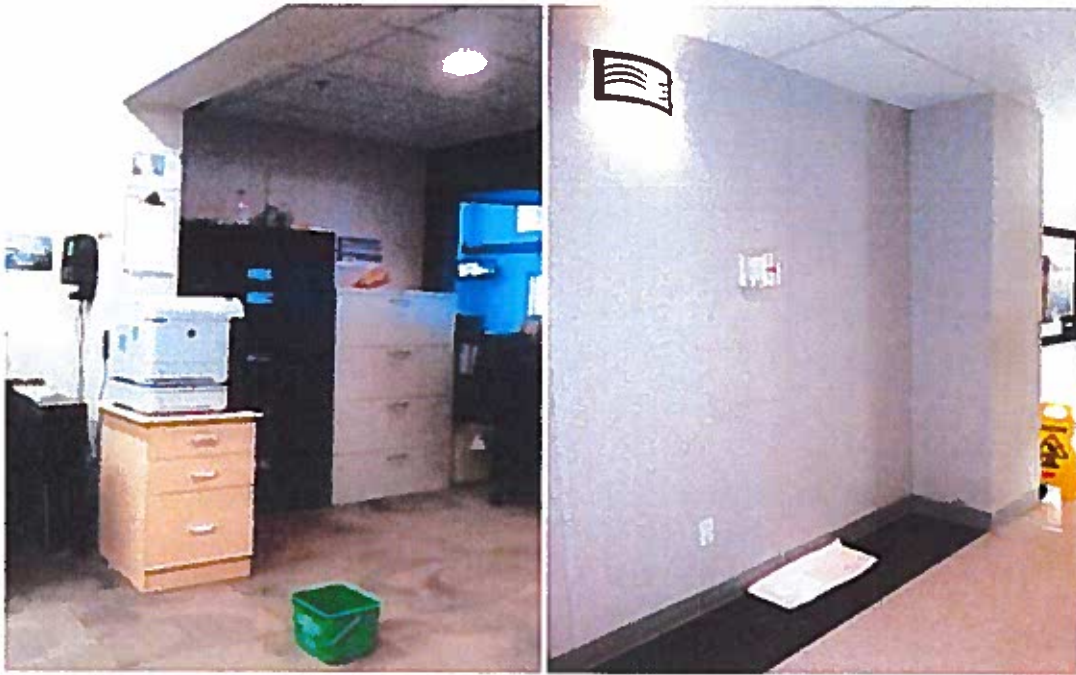
Fig. 76: Bucket collects water dripping from a module junction beam in the front office.

Fig. 77: Towels soak up roof leaks at other locations.

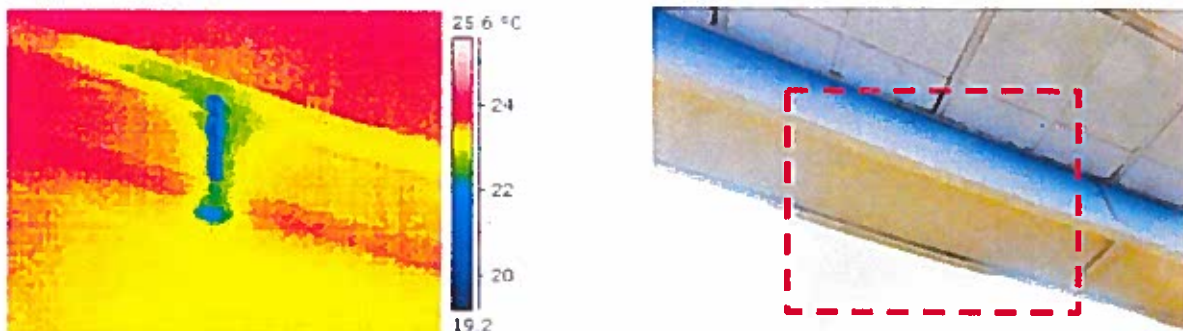
Fig. 78: This long vertical cold spot is likely water running down to the bottom of the beam.

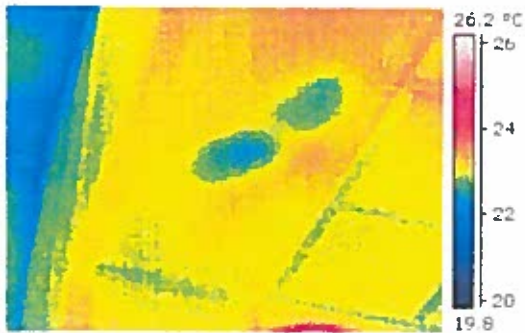
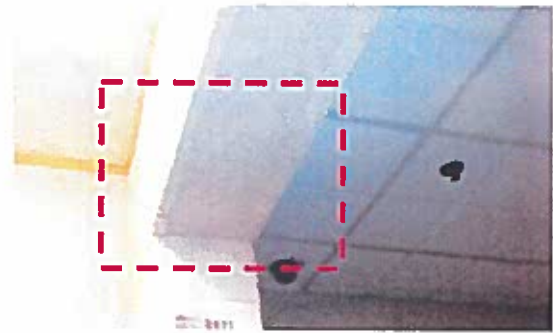
Fig. 79: Two cold spots on the underside of the beam due to moisture.

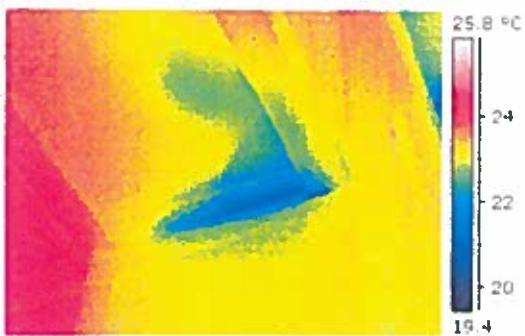
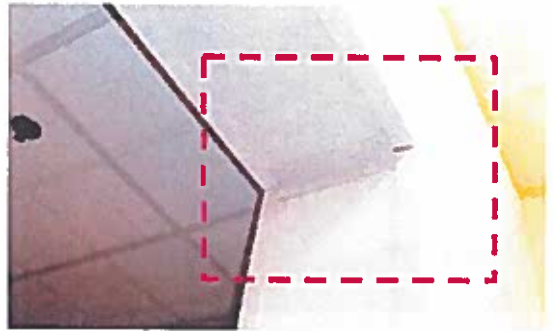
Fig. 80: The end of the beam is showing moisture accumulation.

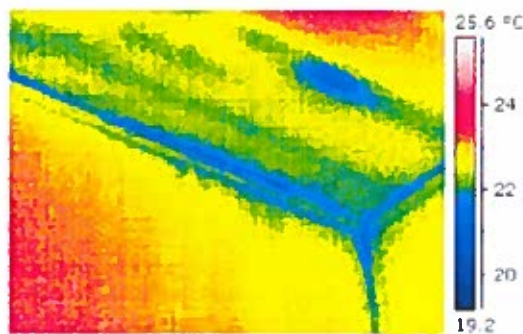
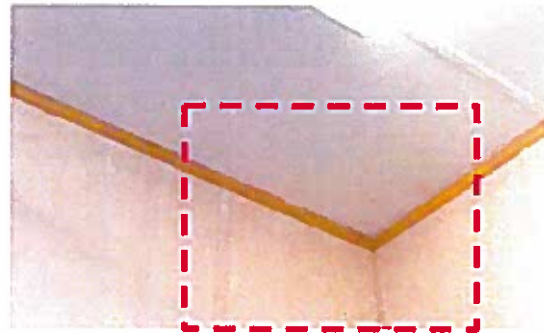
Fig. 82: Cold signatures found in the ceiling of the rear front office.

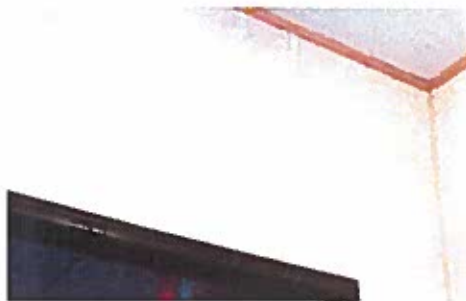
Fig. 83: Water streaks on the wall are evidence of past water leaks.

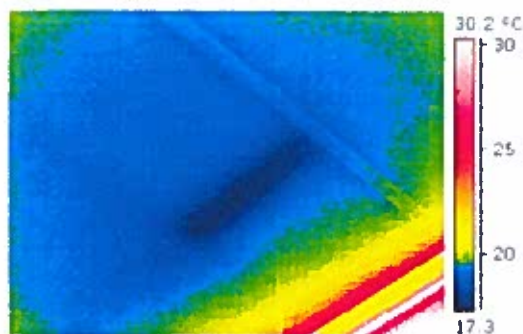
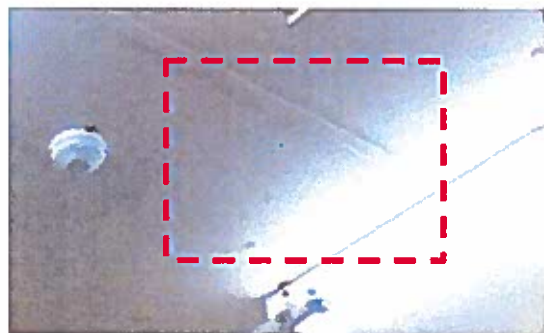
The security office adjacent to the front office is also showing signs of moisture in the ceiling (figure 84). A large cold spot is noted in another corner of this office (figure 85). The adjacent conference room also has evidence of cold spots (figure 86). As mentioned above, some of the cold signatures have been verified with a moisture meter. However, several areas are also moist to touch and others are beginning to show signs of water staining.

Fig. 84: Cold signature in the ceiling of the security office

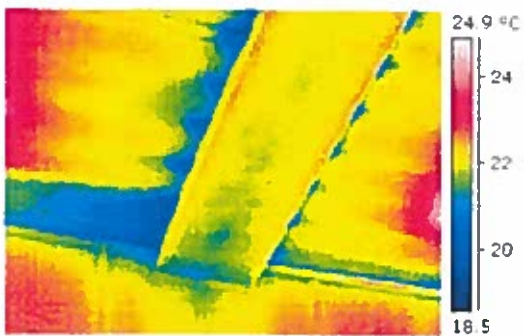
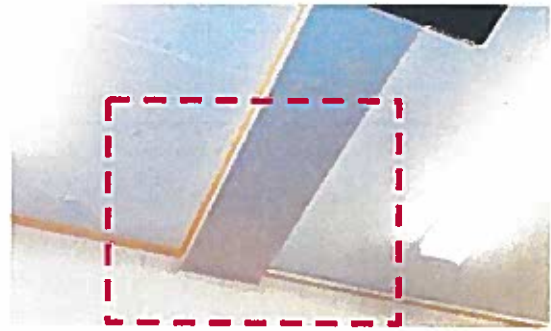
Fig. 86: Cold signatures in the ceiling of the Pakhismtakh (conference room).

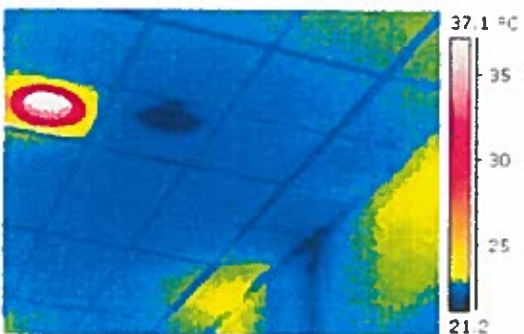
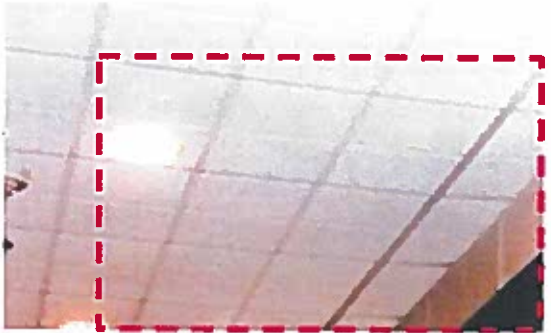
Thermographic scans show many areas of the ceiling in other parts of the building with potential moisture that have not yet penetrated down onto the acoustic ceiling tiles (figure 87). It was reported that ceiling tiles in this building are frequently replaced due to water staining.

Fig. 87: A Water spot above this ceiling tile has not yet penetrated down.

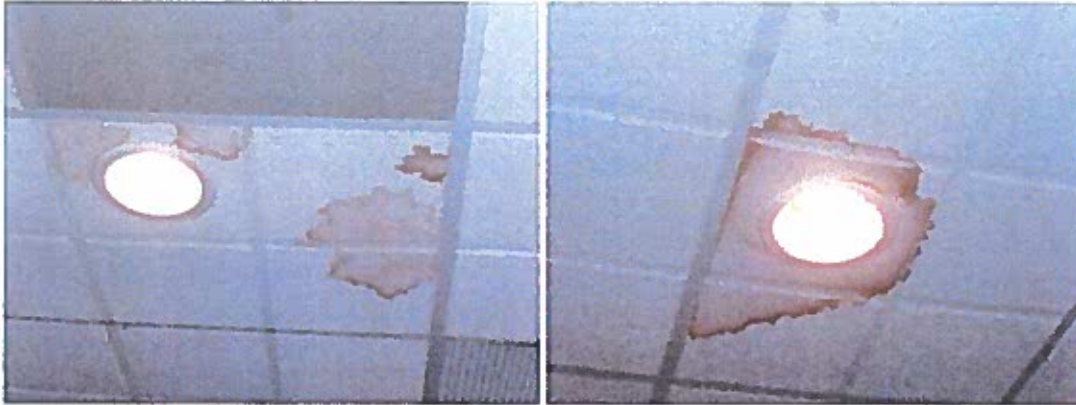
Some water stains are at or very close to the ceiling lights (figures 88 and 89). Some of the water stains are near or on fluorescent lights (figures 90 and 91). Water on an electrical wire can cause an electrical short-circuit and potentially a fire. Water stains are also found around return air and supply air ceiling grilles (figures 92 and 93).

Figs. 88 & 89: Water staining near the lights can cause a short-circuit and fire.

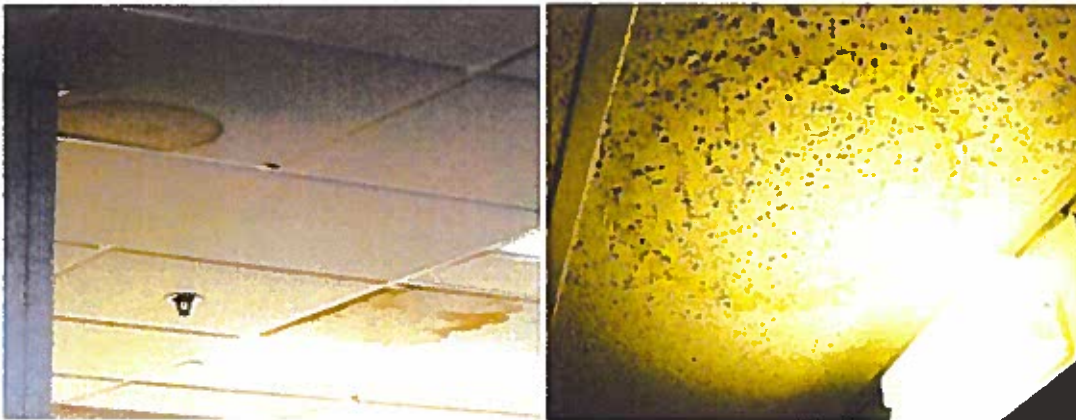
Figs. 90 & 91: Water staining close to electrical lights.

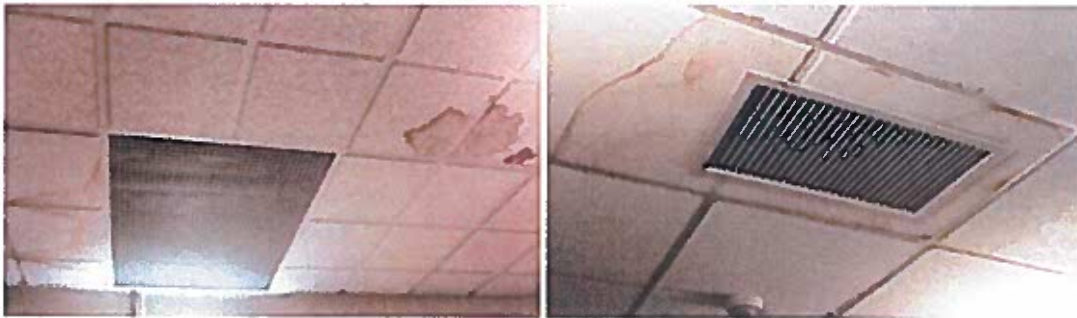
Fig. 92: Water stains around a return air grille.

Fig. 93: Water stains around a supply air registers in the ceiling.

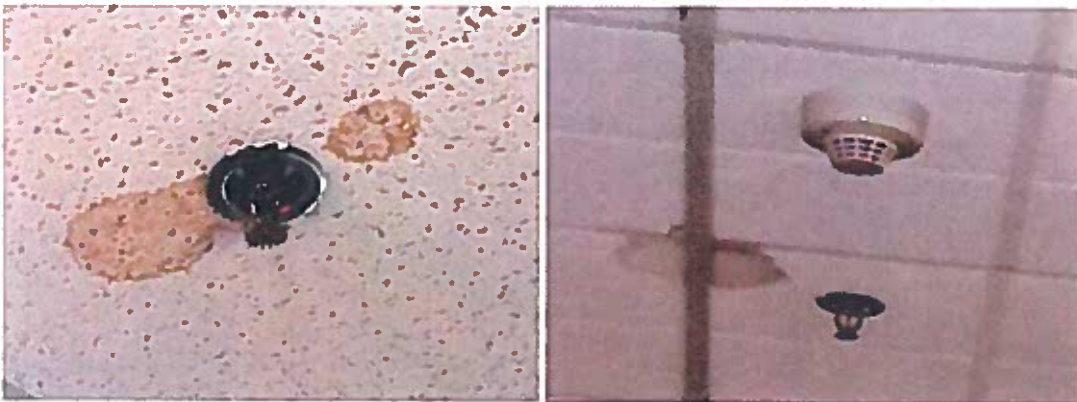
There was a report of leaks from the sprinklers that may cause some of the water stains. However, although some stains are close to the sprinkler heads (figures 94 and 95), they are not necessarily caused by leaks in the sprinkler pipes.

Figs. 94 & 95: Water stains close to the sprinkler heads.

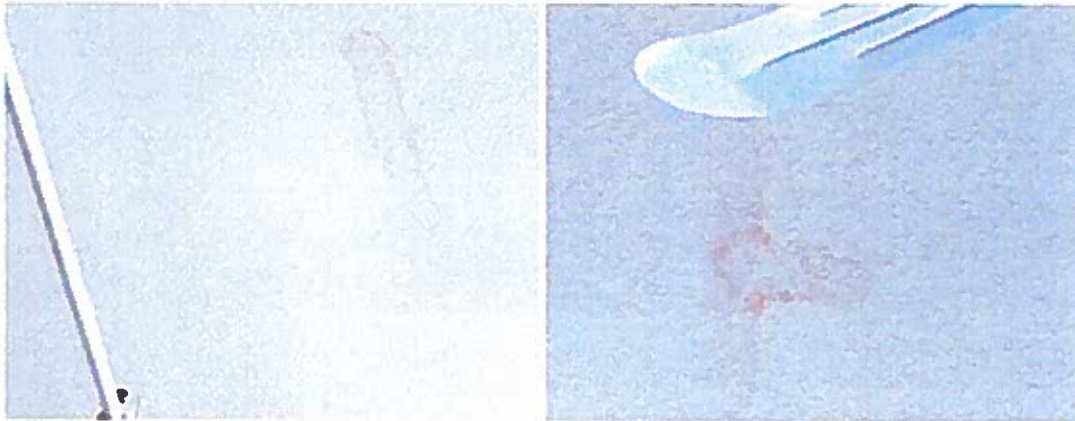
Even the sloped ceiling in the main lobby has evidence of water staining (figures 96 and 97). This may be the result of condensation in the attic due to inadequate attic ventilation.

Figs. 96 & 97: Water staining on the sloped ceiling of the main lobby.

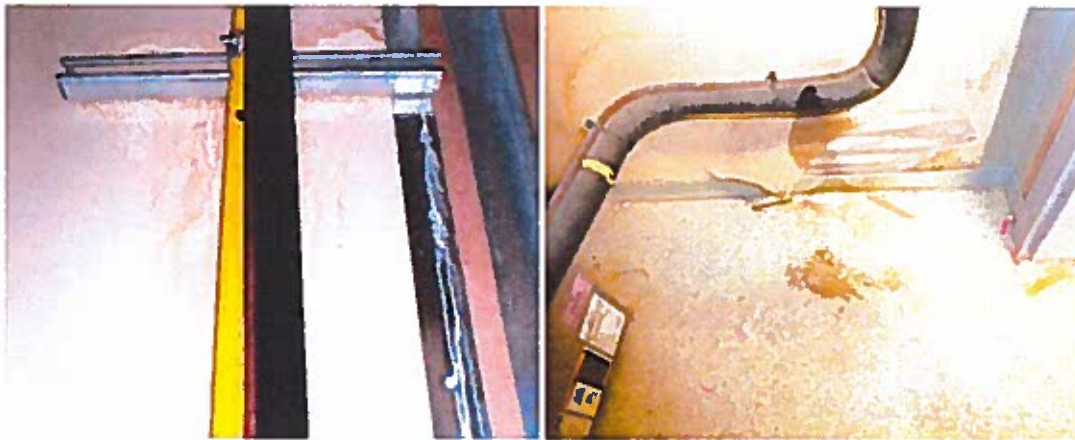
As noted earlier, not only are water stains found on the ceiling, but they are also visible on some walls (figure 98) and floors (figure 99). The water can originate from the roof or from water penetration through walls. Due to building envelope deficiencies, the walls have defects that could be the source of some of these water leaks.

Fig. 98: Water staining on the walls.

Fig. 99: Water dripping down onto the floor and splashing or migrating to the adjacent wall.

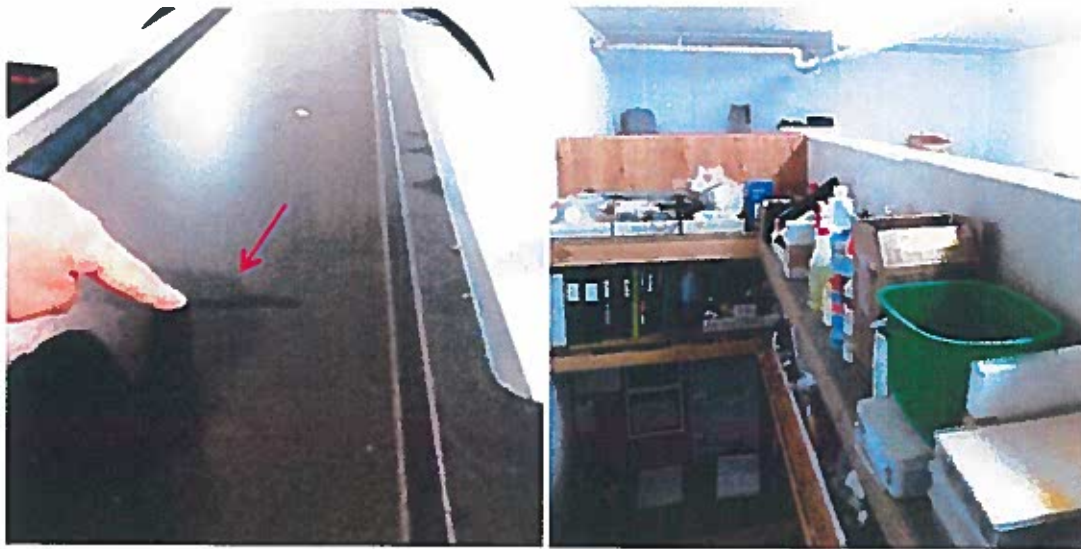
Some of the dust is clearly visible and can be wiped off (figure 102). The top of walls and shelves as well as the contents are covered with a layer of dust (figure 103). Regular maintenance can remove the dust that is easily accessible, but hard to reach areas are less frequently cleaned.

Fig. 102: Dust is clearly apparent on top of this kitchen unit.

Fig. 103: Dust is on top of this pony wall and also on the shelves.

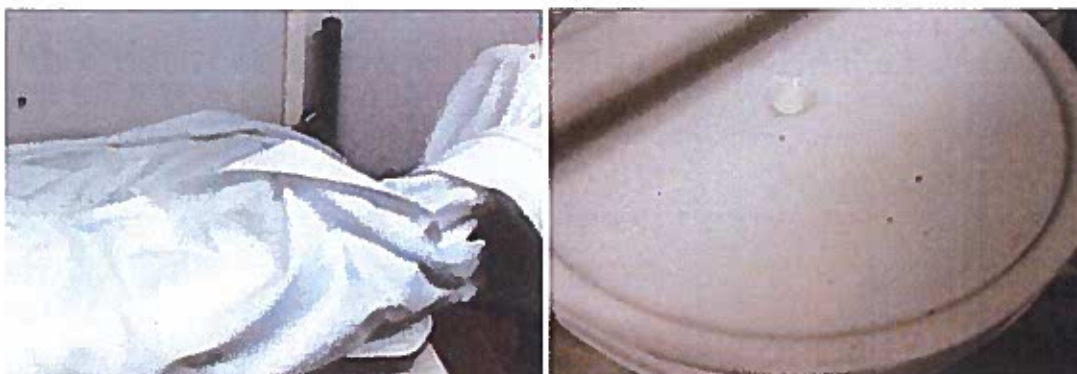
At Conklin Lodge, the kitchen staff has covered much of the stored goods with white cloth to keep the dust and insects off the stored food (figures 106, 107, 108 and 109).

Figs. 108 and 109: Insects are drawn into the kitchen as seen on top of these cover cloths and white plastic containers.

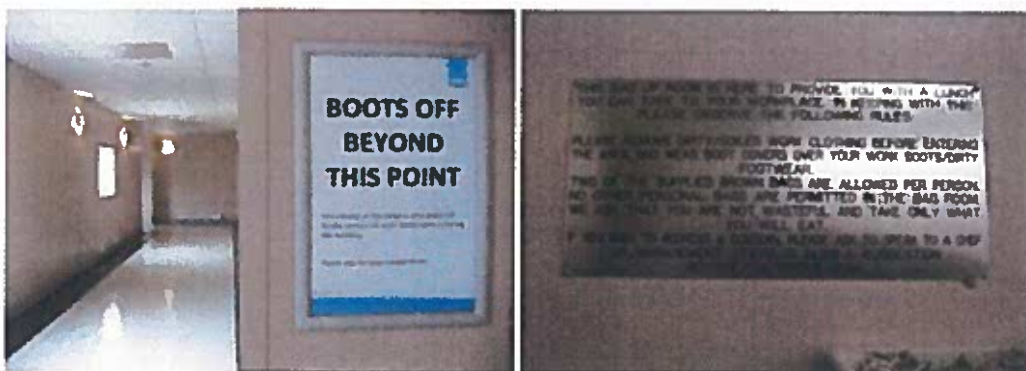
Fig. 110: Boots off sign posted.

Fig. 111: The second paragraph of this posted sign in the bag up room requests that dirty clothing and footwear be removed before entering.

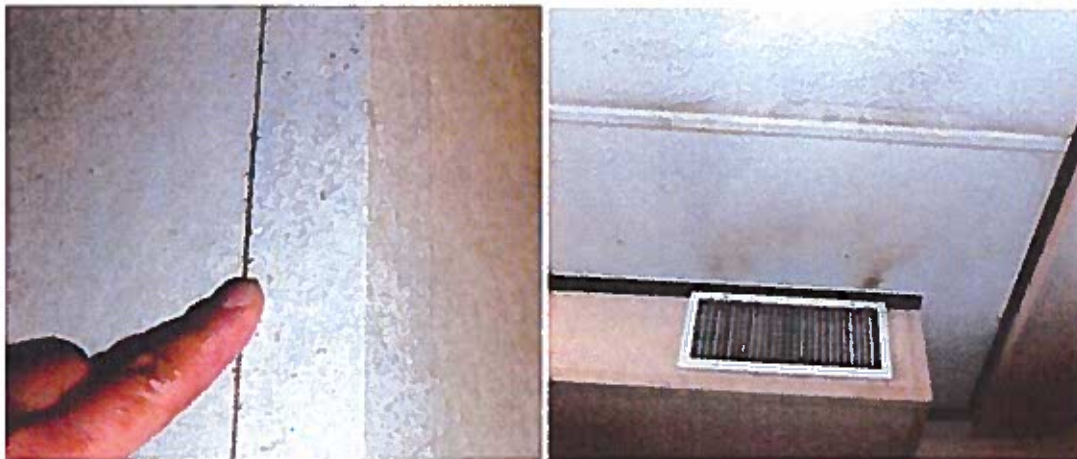
There is dust throughout the building as can be seen in the dust build-up in the games room (figure 114). Air supply grilles to the room are very dusty as shown by the dust in the ceilings (figures 115 and 116). The return air grilles in the wall and ceiling are covered with dust (figure 117). Top of pipes and ceiling fans are also covered with dust (figures 118 and 119). Many of these locations are difficult to access and therefore receive less maintenance.

Fig. 114: Dust is visible on walls and columns inside this building.

Fig. 115: Dust on the ceiling is from the air supply.

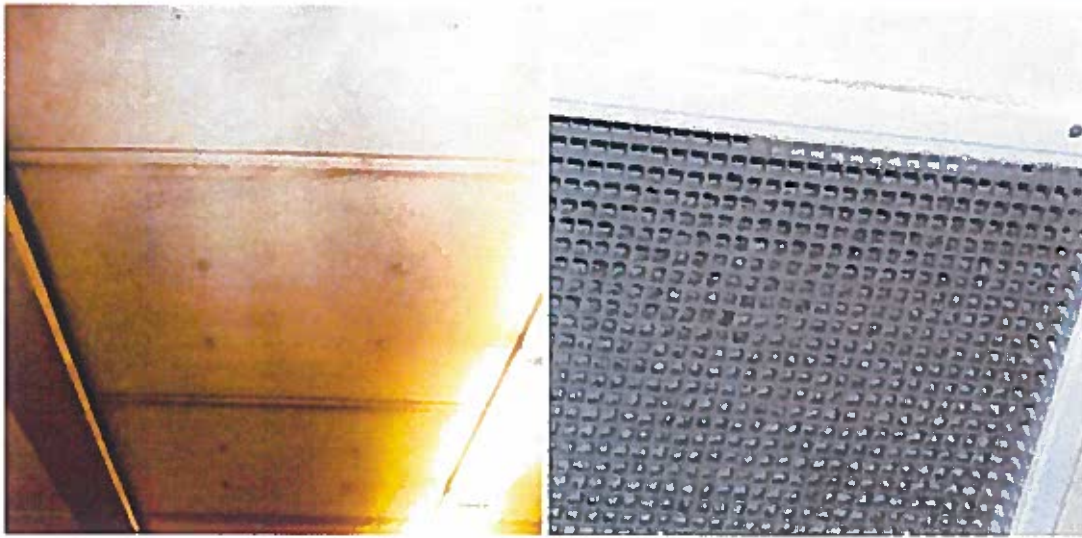
Fig. 116: Visible dust on the ceilings emanates from the air supply to this room.

Fig. 117: This egg crate ceiling vent is covered with dust.

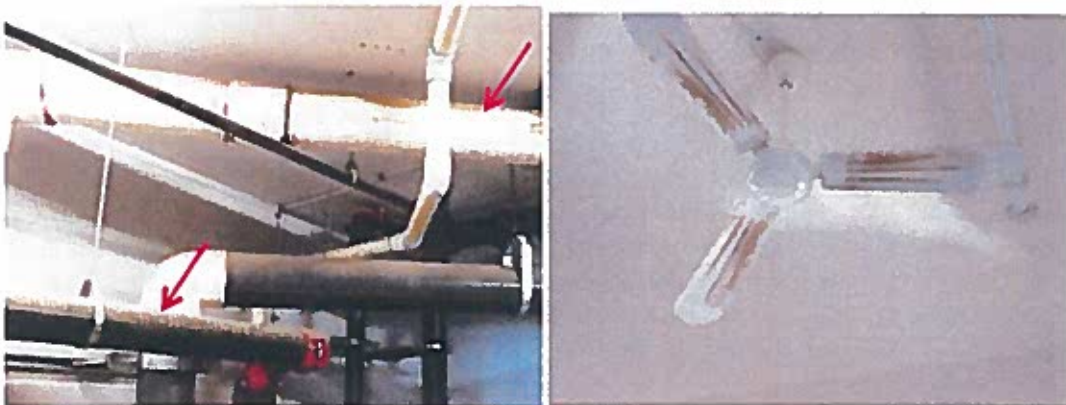
Fig. 118: Dust is found on top of pipes.

Fig. 119: Dust on ceiling fan.

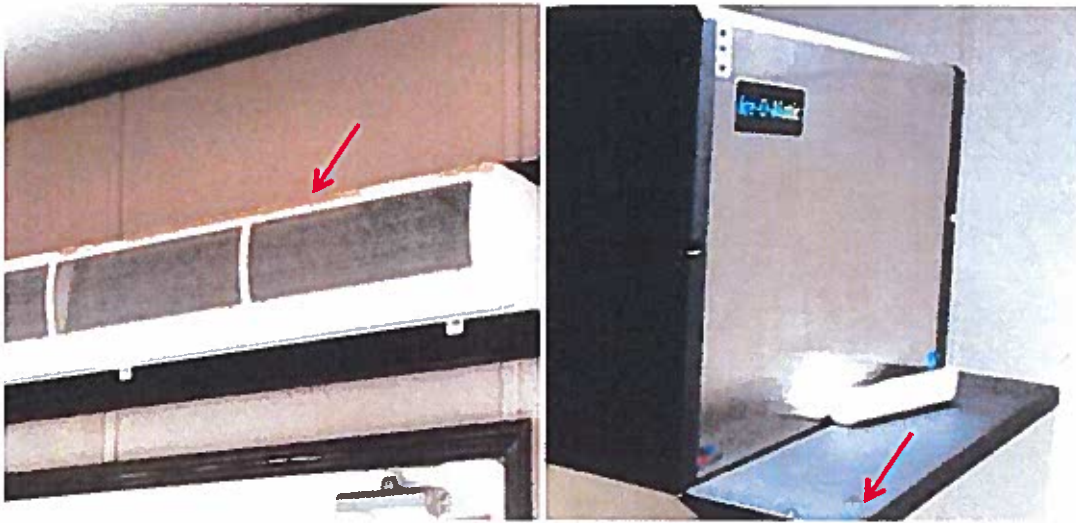
Brown coloured dust can be clearly seen on top of the heater above the main entrance (figure 120). Dust is also visible on top of the ice-making machines in the wings (figure 121).

Fig. 120: Considerable dust on this space heater above the front entry door.

Fig. 121: Dust collecting on the ice-making machine in the residential wings.

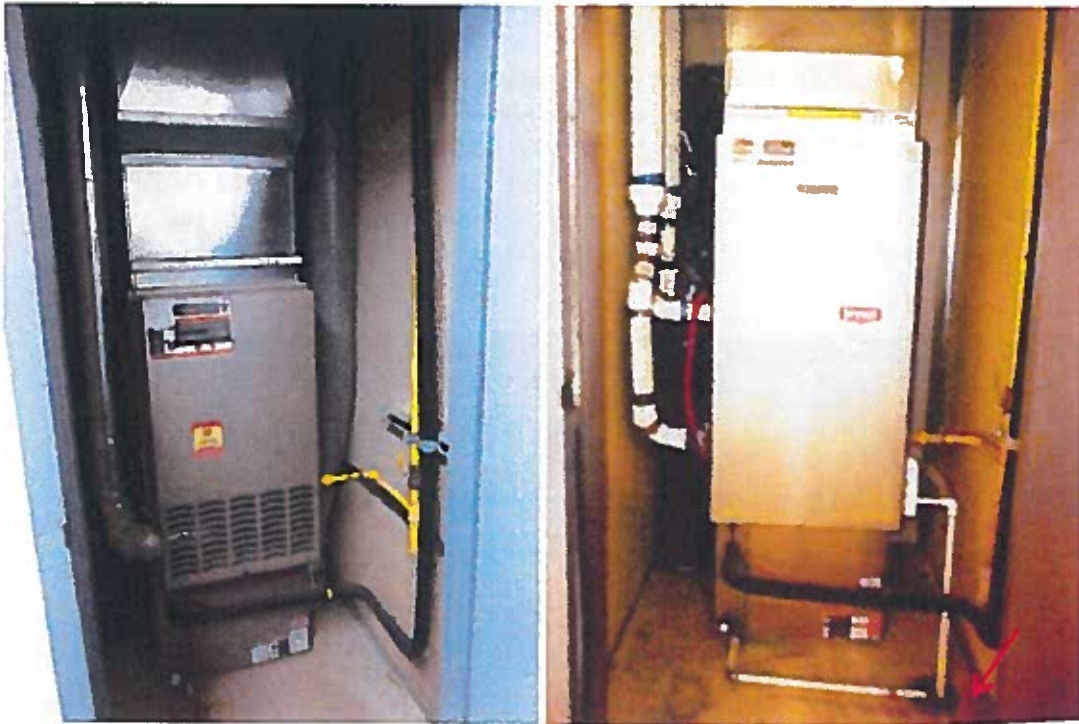
Fig. 122: Furnace room in women's exercise room.

Fig. 123: Furnace room in the Lounge has a high efficiency furnace with no need for a chimney.

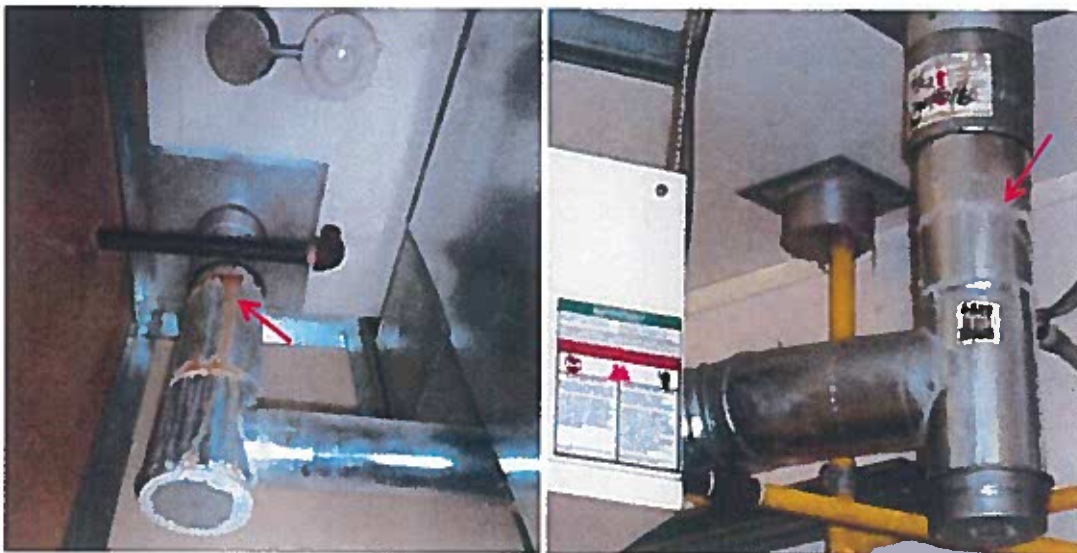
Fig. 124: Water leaking down the chimney of this furnace.

Fig. 125: Space heater chimney with water leaking down.

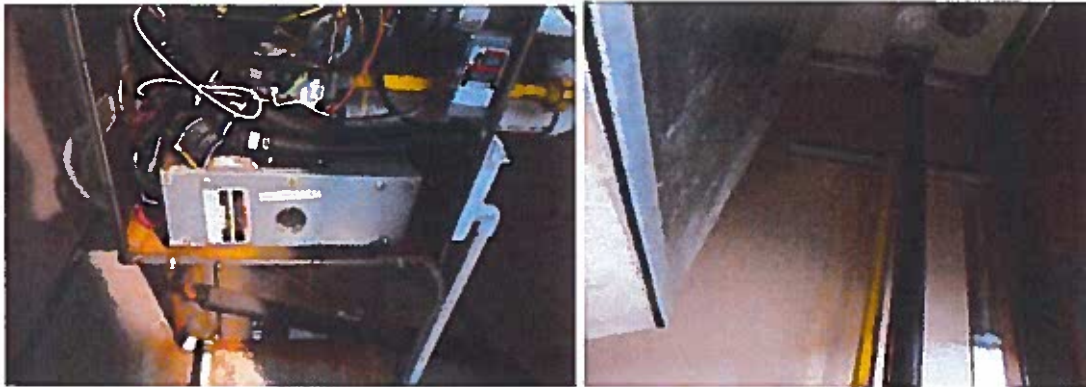
The furnace in the lounge is a combination of high efficiency heating and cooling unit. Water staining and rust on the bottom part of the furnace and the floor may be caused by water intrusion into the unit from the air intake duct (figure 126). The furnace room in the women's exercise room had experienced a water leak. Water may have leaked into the room through the conduit, which fitted the propane pipe and condenser lines to the roof (figure 127). Water leaked all the way down to the floor along the wall and mould grows on the drywall close to the floor (figure 128).

Fig. 126: Water stain and rust in the lounge furnace.

Fig. 127: Water leaked into the furnace room from through roof conduit.

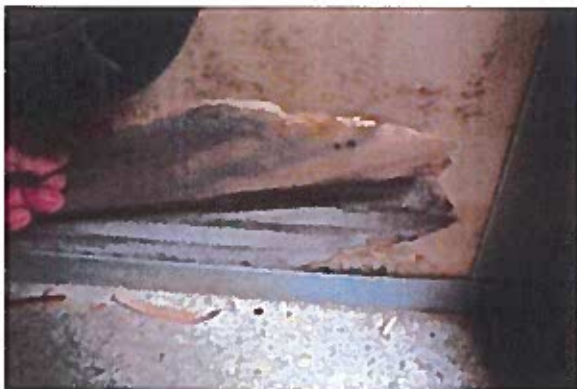
Fig. 128: Mould grows on the drywall close to the floor.

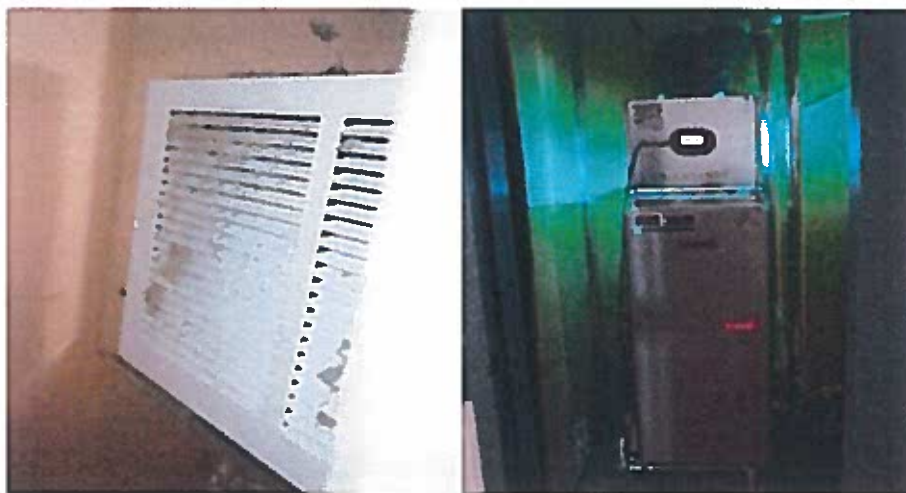
Eight furnaces in Wing 47 were randomly selected and examined. Some of the furnaces were in fair condition and some were very dusty. There was dust and hair on the return air grille of some furnaces (figure 129). All furnaces were equipped with UV light on upstream airflow of the pleat filter to neutralize bacteria, viruses and mould particles (figure 130). The condition of the furnace filters was

Fig. 129: Dust and hair on the return air grill on the furnace.

Fig. 130: Typical furnace in wing 47 with UV light.
