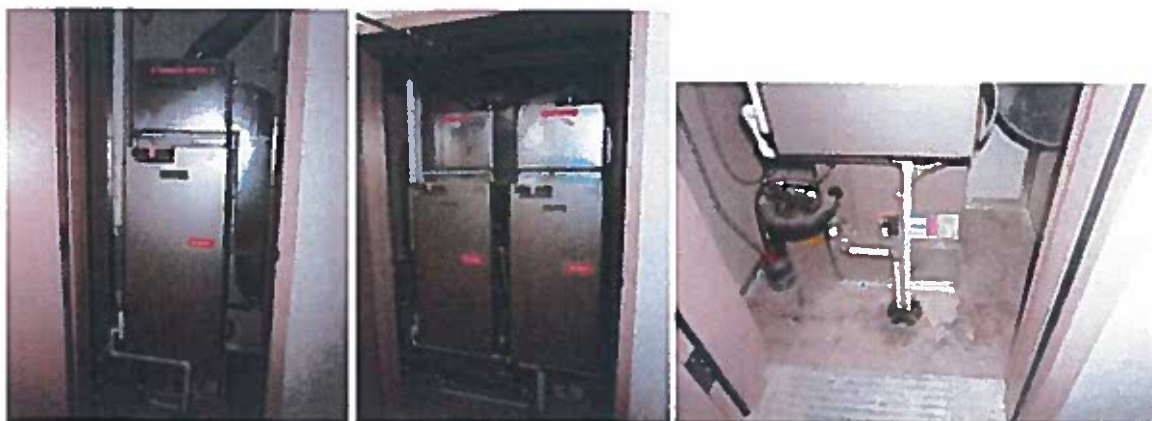
In wing 45 the furnaces were without UV light. The configuration of the furnace rooms is different than wing 47: some consist of one furnace (figure 131) and some have two furnaces (figure 132), each furnace serving one guest room. In general, the floors in all furnace rooms were dirty and dusty (figure 133).

Fig. 131: The furnace without UV light in wing 45.

Fig. 132: Two furnaces share one furnace room in wing 45.

Fig. 133 : Dirty and dusty furnace room floor.

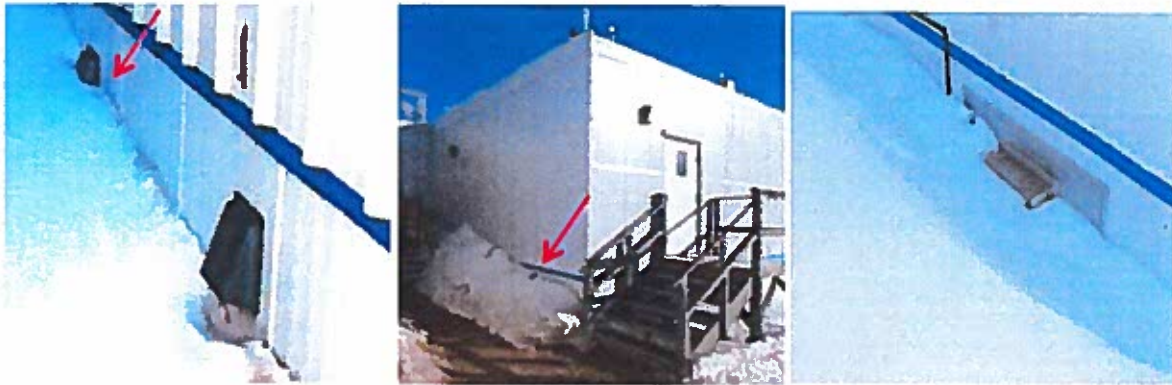
Fig. 136: The air intake hood at the back of photo is blocked with snow.

Fig. 137: Fresh air intake for this furnace is completely covered with snow.

Fig. 138: This damper air intake is completely blocked by snow.

Some of the vents with dampers are also blocked by snow, thus preventing any outside air to be drawn into the building (figure 138). This lack of air supply can compromise the efficiency of the furnace, or cause chimney backdrafting due to absence of combustion air (figure 139). Carbon monoxide build-up can occur due to negative air pressure differential caused by exhaust fans or wind flow and direction.

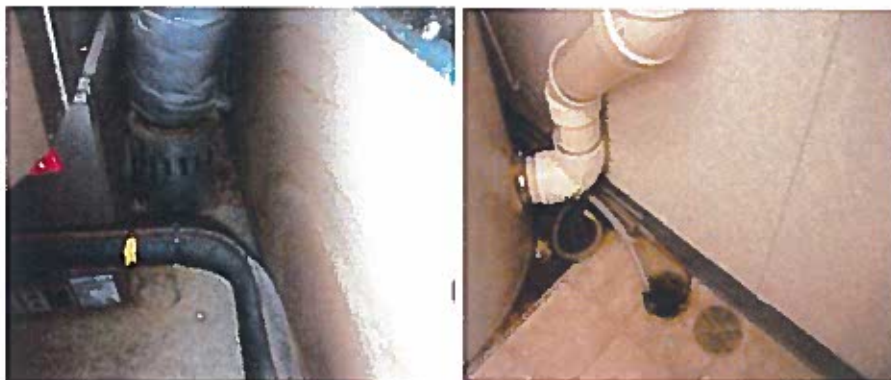
Fig. 139: Combustion air discharged onto the floor of the furnace room.

Fig. 140: Condensate is allowed to drain through a hole in the floor down into the crawlspace.

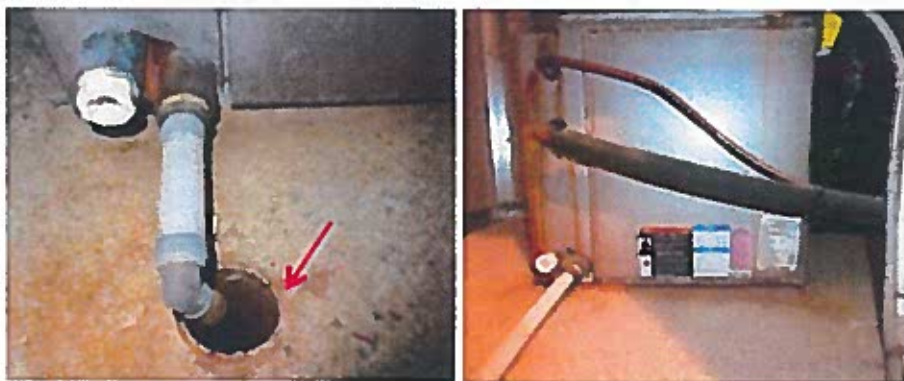
Combustion condensate from the furnace drains away through a hole in the floor (figures 140 and 141). The hole allows the condensate to discharge directly into the crawl space. High efficiency furnaces have considerably more condensate and those are also discharged directly down into the crawl space (figure 142). This water adds to the moisture in the crawl space increasing the potential for mould growth. The gaps around the floor penetration allow contaminated crawl space air to migrate up into the conditioned building through stack effect.

Fig. 141: Condensate drains down this hole in the floor of the furnace room.

Fig. 142: This high efficiency furnace has considerably more condensate, which is also discharged into the floor of the crawlspace.

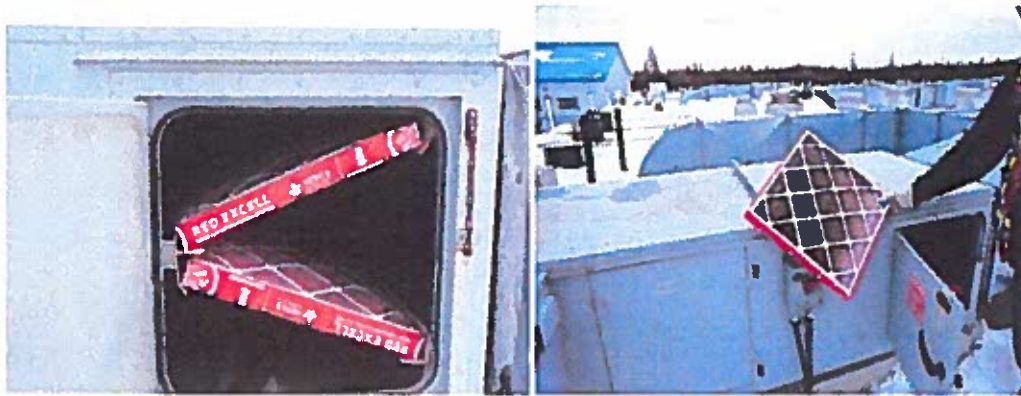
According to the information from the maintenance technician, the filters in the MUA are replaced once every month in winter and once every two weeks after all the snow has melted. The replacement date was not marked on any filters. Most of the filters were very dirty and dusty (figure 150).

Fig. 150: Dirty filter from a make-up air unit

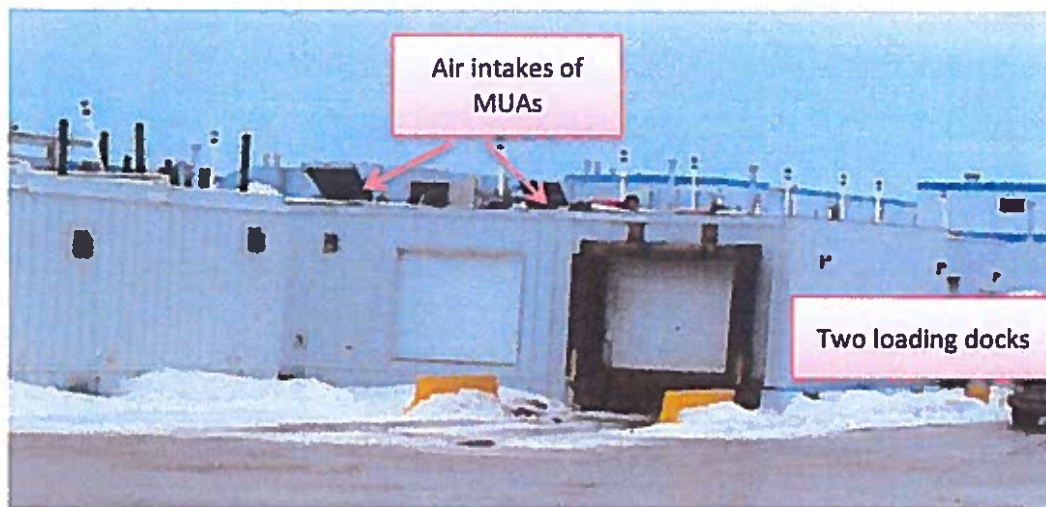
Fig. 151: MUA air intake located close to loading docks.

Two MUA units are located within twenty feet from two loading docks near the kitchen (figure 151). Another MUA was installed on the roof close to the roadway where the buses congregate to pick up or drop off personnel. We observed delivery trucks idling adjacent to the front lobby where the MUA unit air intake was about thirty feet away (figure 152). Another delivery truck was idling in front of the flight centre near several MUA units (figure 153).

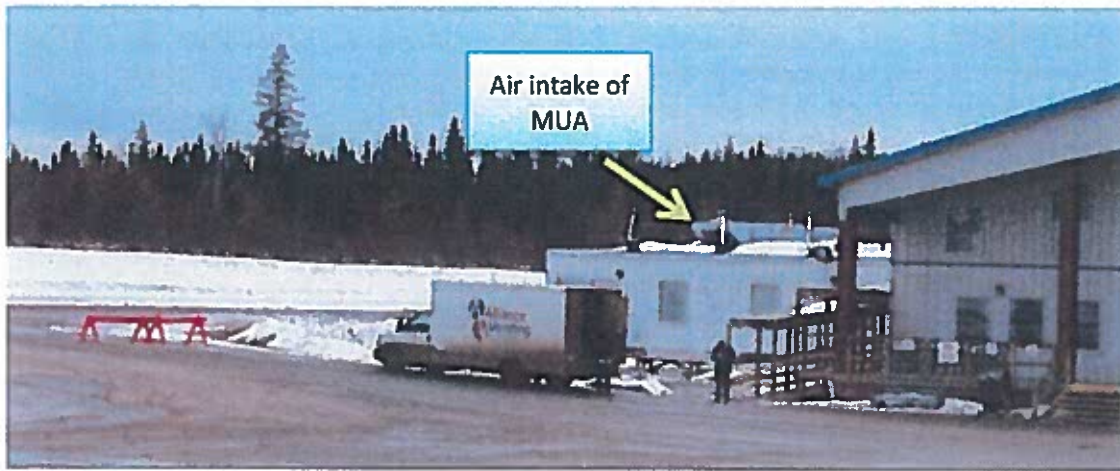
Fig. 152: Delivery truck idling near air intake of MUA

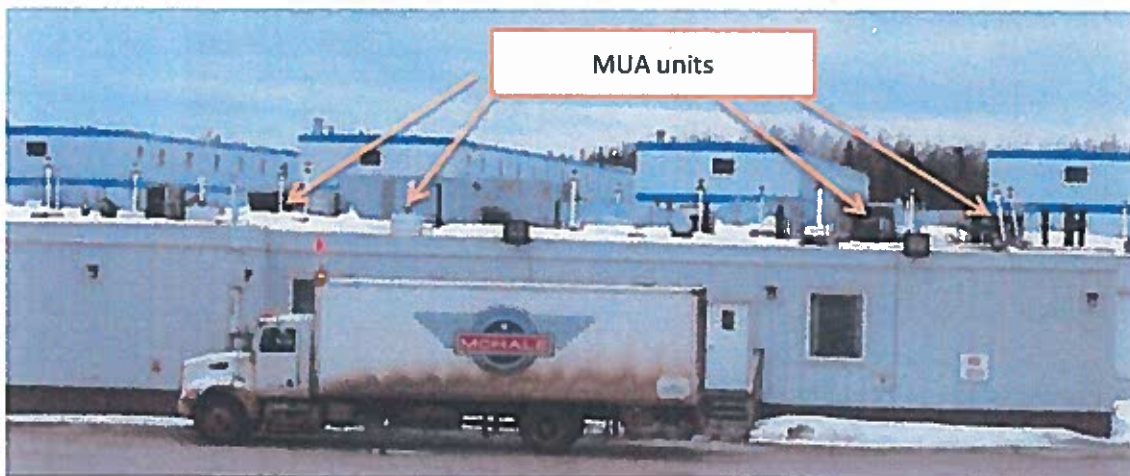
Fig. 153: Delivery truck idling near MUA unit

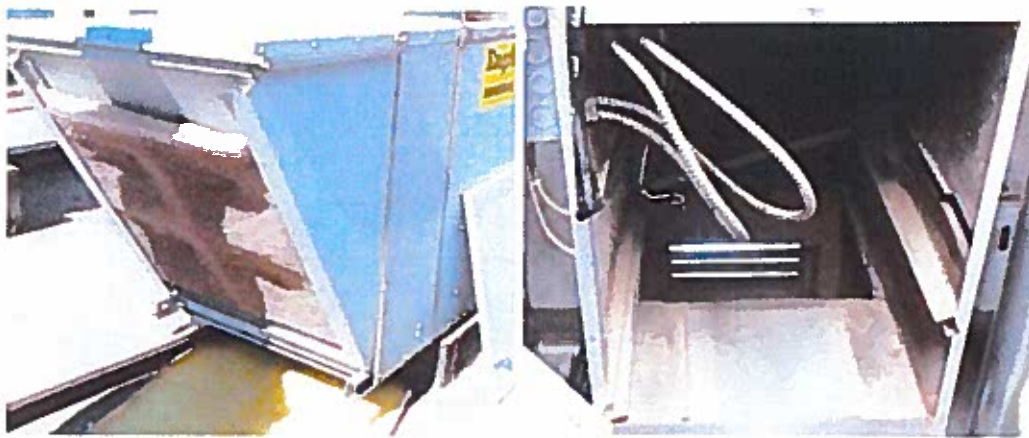
Vehicle traffic and wind will stir up dry exposed dirt on the ground. During our examination, the ambient air was not particularly dusty because the ground was moist due to spring melt. Considerably more airborne dust is experienced in summer months as reported by the workers. Nevertheless, even under conditions with little dust in the air, we examined the roof top units and found them to be very dusty. The air filters are clogged with dust (figure 154). It is apparent that significant dust had bypassed the filter to enter into the rooftop units and subsequently into the conditioned space below (figure 155). Some of the direct-fired units serving the kitchen are very dusty (figures 156 and 157). The dust enters the air intake of the direct-fired units, passes through the filters, burns in the flames, and then releases soot and other by-products of combustion directly into the building.

Fig. 154: Large amount of dust in the ambient air clogs up the air filters on the rooftop units.

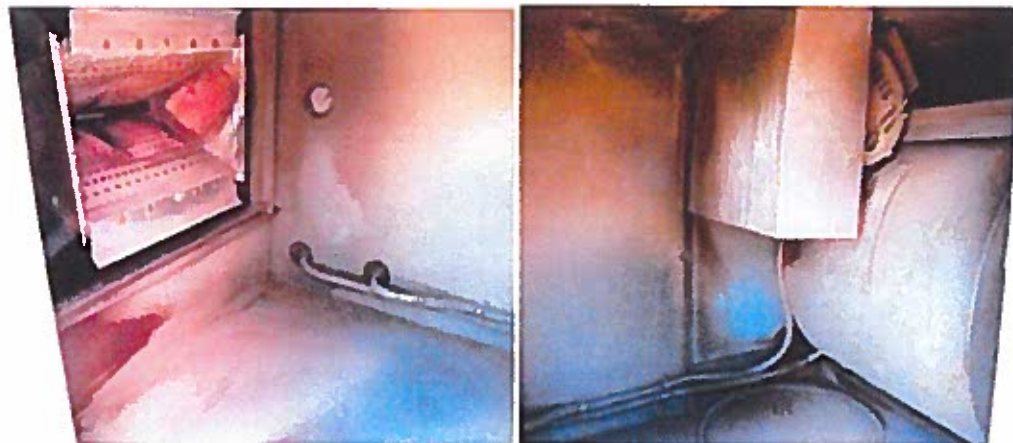
Fig. 156: Dust is drawn into these direct-fired units.

Fig. 157: Considerable dust is found inside all of the furnace units.
