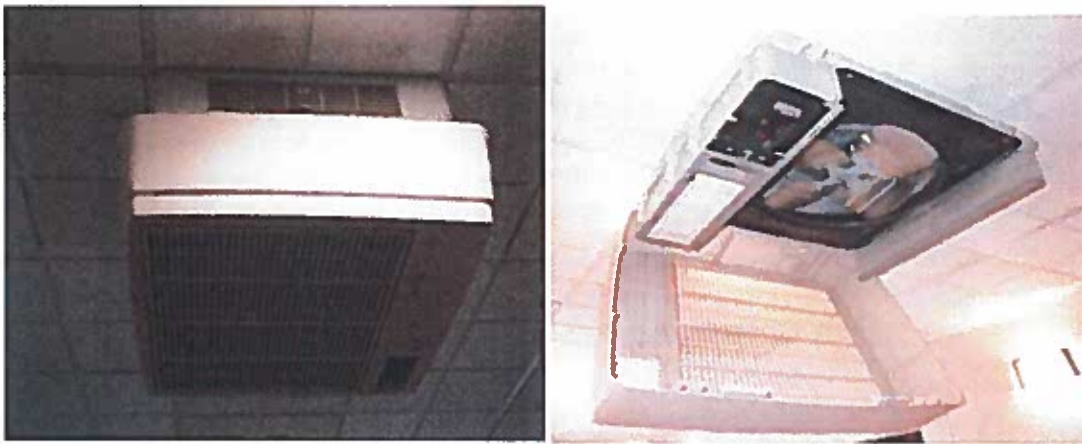
In an attempt to reduce the dust accumulation inside the buildings, ceiling mounted air filtration equipment has been installed (figures 158, 159). These are electronic filters that use a corona wire to provide a positive charge to the dust particles. Metal plates, which are negatively charged, attract the positively charged dust. In theory it should be about 80% efficient in reducing airborne particulates. However, these electronic air filters lose efficiency quickly when a thin coating of dust accumulates on the plates rendering them ineffective in a very short time (figure 160). It was reported that there is a weekly cleaning schedule for these plates (figure 161). Considering the amount of dust that accumulates particularly during dry seasons, these plates should be cleaned daily.

Figs. 158 and 159: Ceiling mounted air filtration unit.

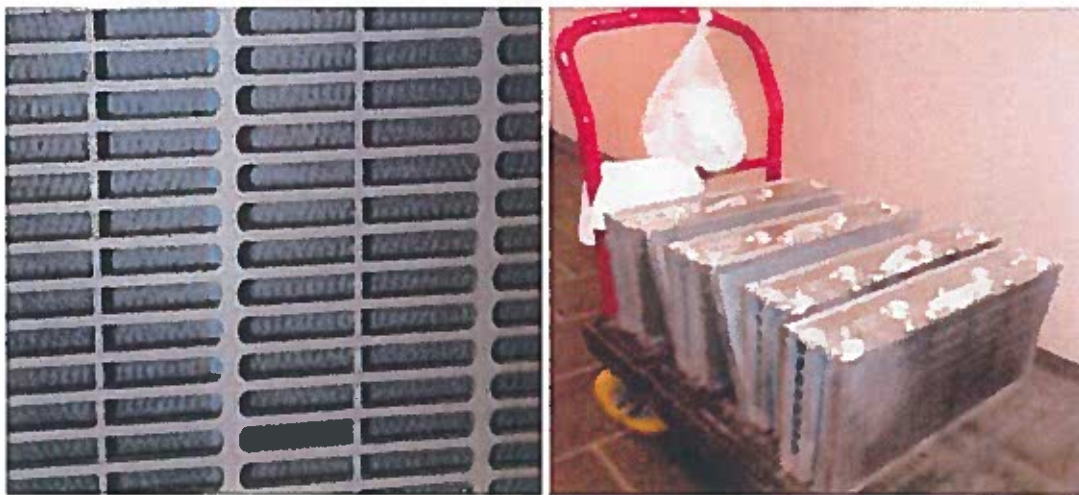
Fig. 160: Ceiling mounted air filtration unit with dust-plugged filter.

Fig. 161: Electronic air filter plates are removed and cleaned by rinsing with water.

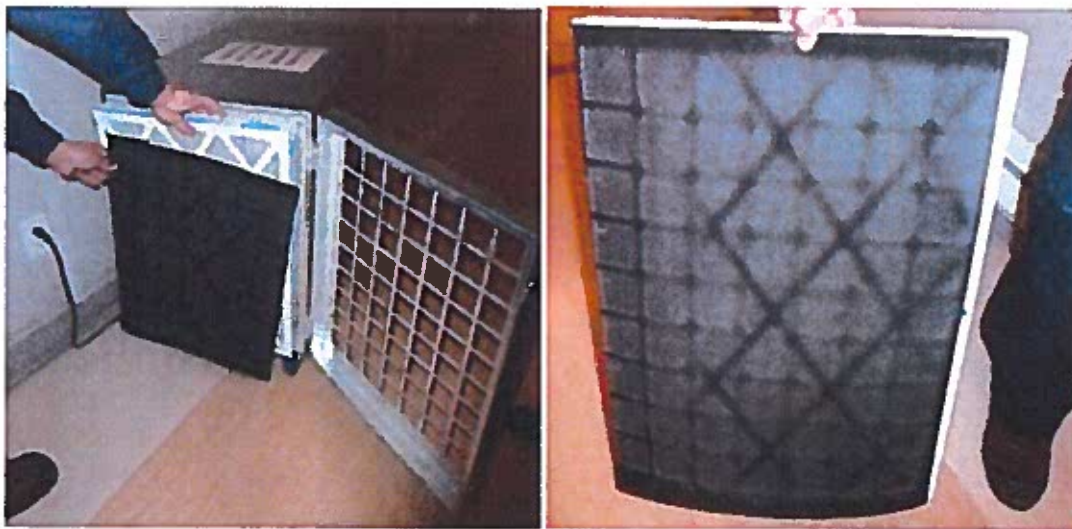
Fig. 162: A medium-efficiency second stage pleated filter is located behind the first stage pre-filter.  
Fig. 163: Dust on the black of the first stage pre-filter.

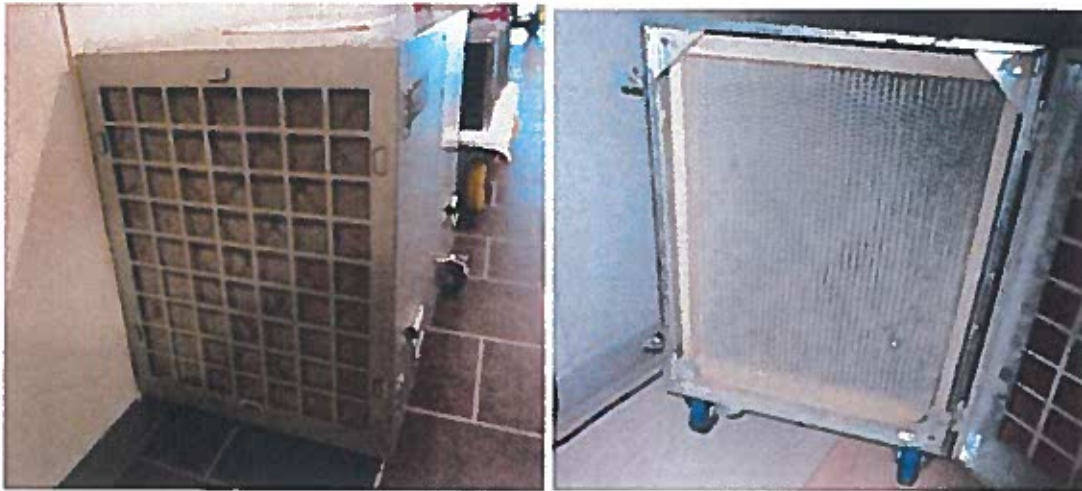
Fig. 164: Very dirty second stage pleated filter found on this air scrubber.

Fig. 165: This HEPA filter can only be serviced by the manufacturer. Its replacement schedule is unknown.

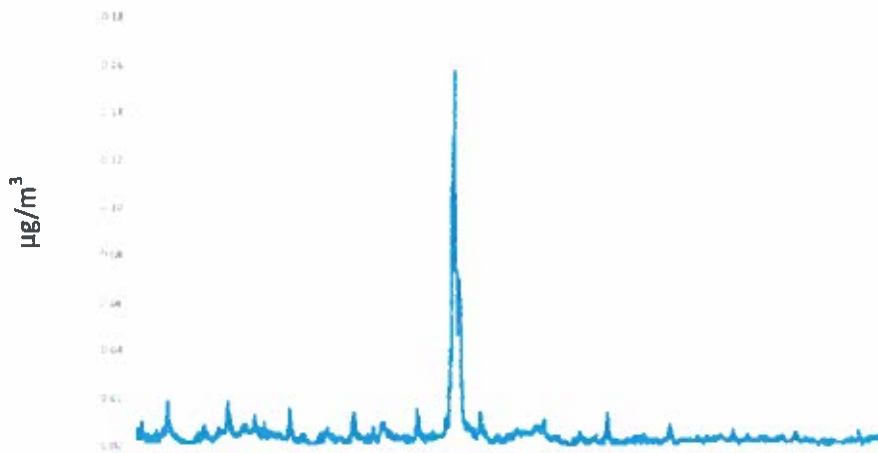
Fig. 170: Airborne Particulates in Bag-up Room

All airborne particulate concentrations PM2.5 were well under the guideline of being less than outdoor levels, which is recommended to be less than  $30\mu\text{m}/\text{m}^3$ . The highest level measured was in the bag-up room where concentrations rose to  $0.16\mu\text{m}/\text{m}^3$  for a short period of time. The lobby also experienced a spike in PM2.5 concentrations at the same time.

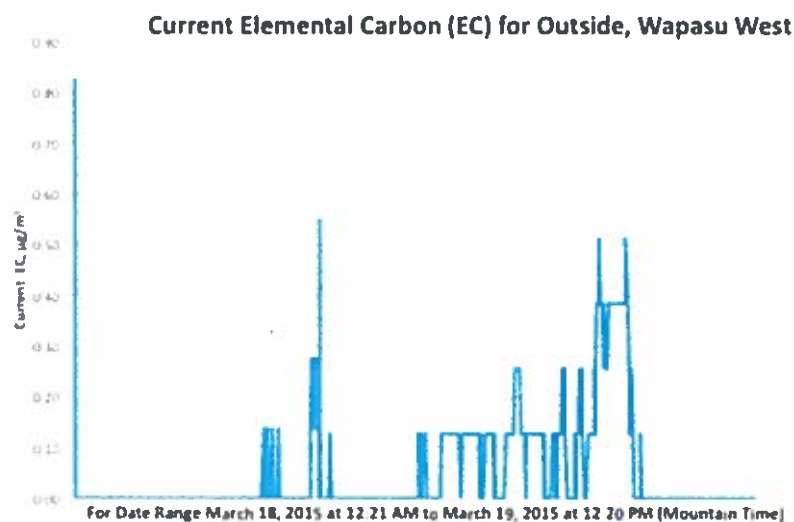
The 24-hour TWA for outdoor concentration of DPM was  $0.05\mu\text{g}/\text{m}^3$ . There were two peaks that went up to  $0.55\mu\text{g}/\text{m}^3$  on March 18 and up to  $0.51\mu\text{g}/\text{m}^3$  on March 19 (figure 172). Roughly at the same time each day, these two peaks may indicate a truck idling at a loading dock.

Fig. 172: Diesel Particulate Outside

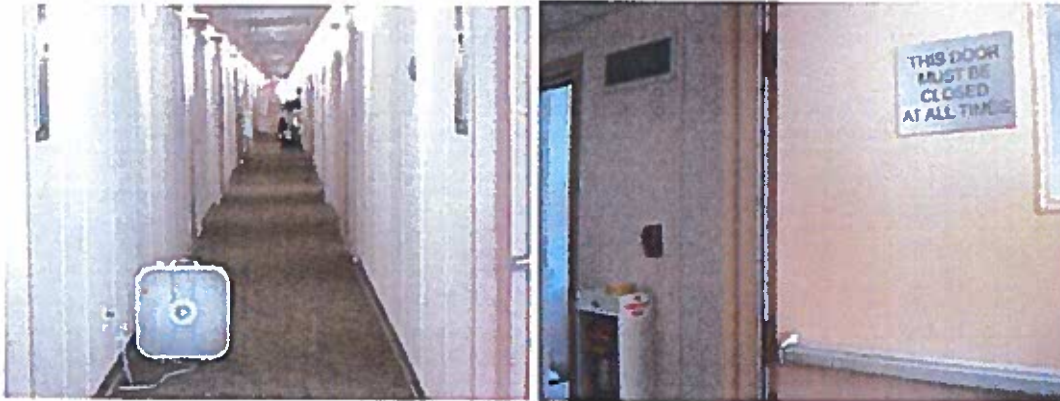
Workers reported having to work in hot temperatures particularly in the summer months. The stairwells in the wings have no fresh air supply and can become very hot especially as heat rises to the third floor due to stack effect. Some of the wings have no fresh air supply and housekeeping staff bring in portable fans in order to provide some air movement while they carry on with their work (figure 173). They also prop open doors at the end of hallways in order to keep the air moving despite the fact that there are signs on the doors to keep them closed for fire reasons (figure 174).

Fig. 173: Portable fan in Wing.

Fig. 174: Door closure notice.

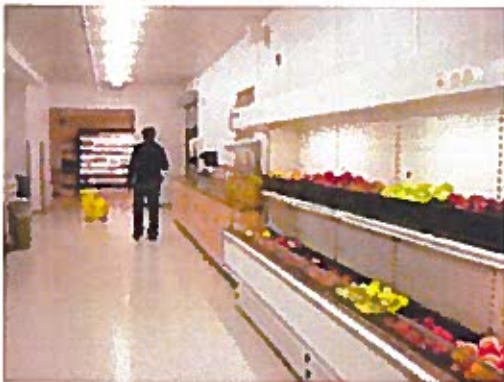
Workers also reported temperature issues in the bag up room on summer mornings when the oil field employees are filing through before they go to work.

Fig. 175: Bag-up room becomes hot and stuffy on crowded summer mornings.

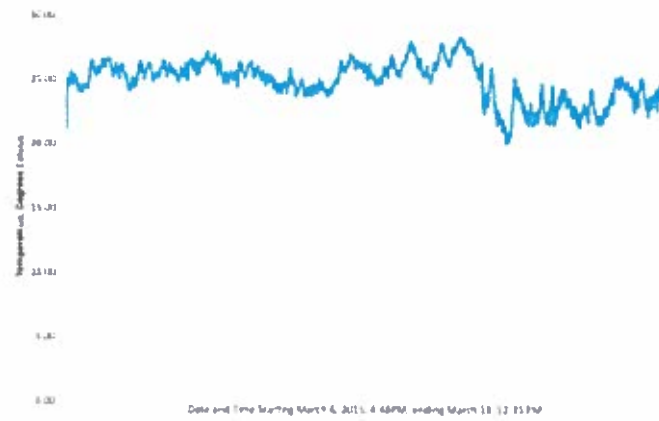
Fig. 177: Bag-up Room Temperature

Temperature measurements at four indoor locations were generally 20-24°C. The bag-up room tended to be a little warmer for the first ten days and then dropped (figure 175). Two major fluctuations happened in the kitchen about the same time. Housekeeping also experienced a fluctuation.

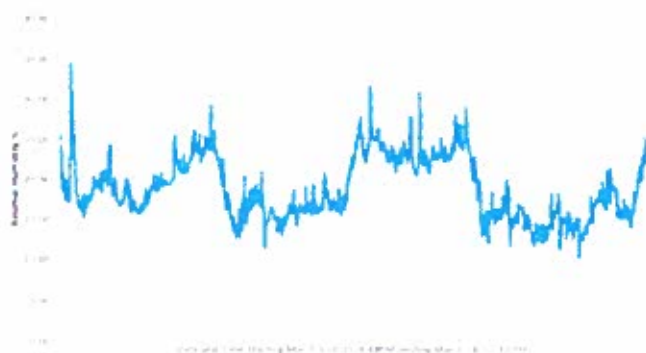
Fig. 183: Relative Humidity Housekeeping

The 10%RH in housekeeping is somewhat low, but the other areas are within the guidelines of 20-30%RH in winter in Alberta.
