MEMORANDUM

TO: John Dhaliwal, Review Officer
FROM: James A. McJannet, Barrister & Solicitor, Investigations
Legal Officer
DATE: January 6, 2012
SUBJECT: Request for Review - RFR #R0130850
RFS 201100256
Administrative Penalty IR 2011110870029
Applicant/Firm: Peter Kiewit Infrastructure Co.
Firm No.: 76110

Officer Barbara Deschenes' Response to Employer's Submission

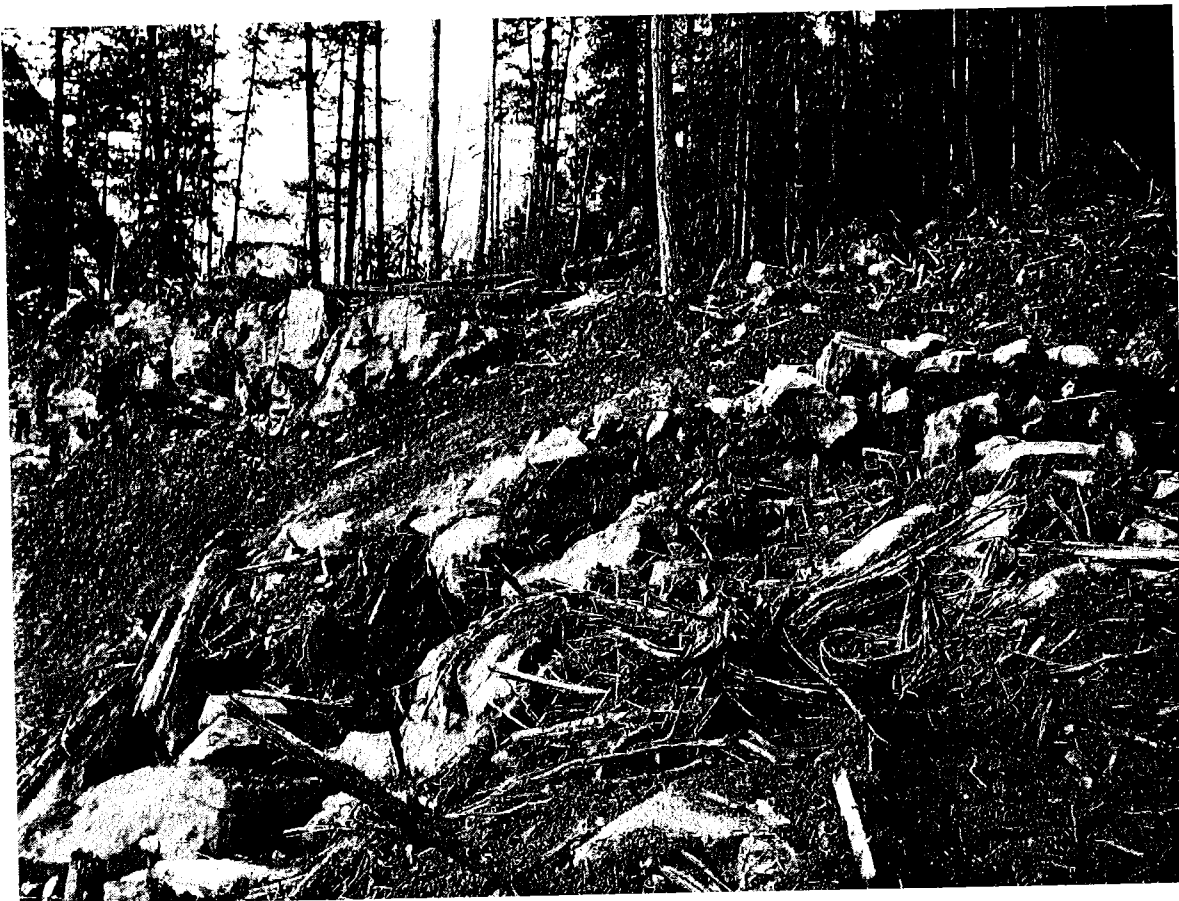
Photographs taken at the accident site show the obviously hazardous unstable materials present on the uphill slope.

Disclosure document 035 - *Photos - OSO Lunny x 71*, photo 23, above, shows the "verge" of the unscaled uphill area and the previously scaled smooth area.

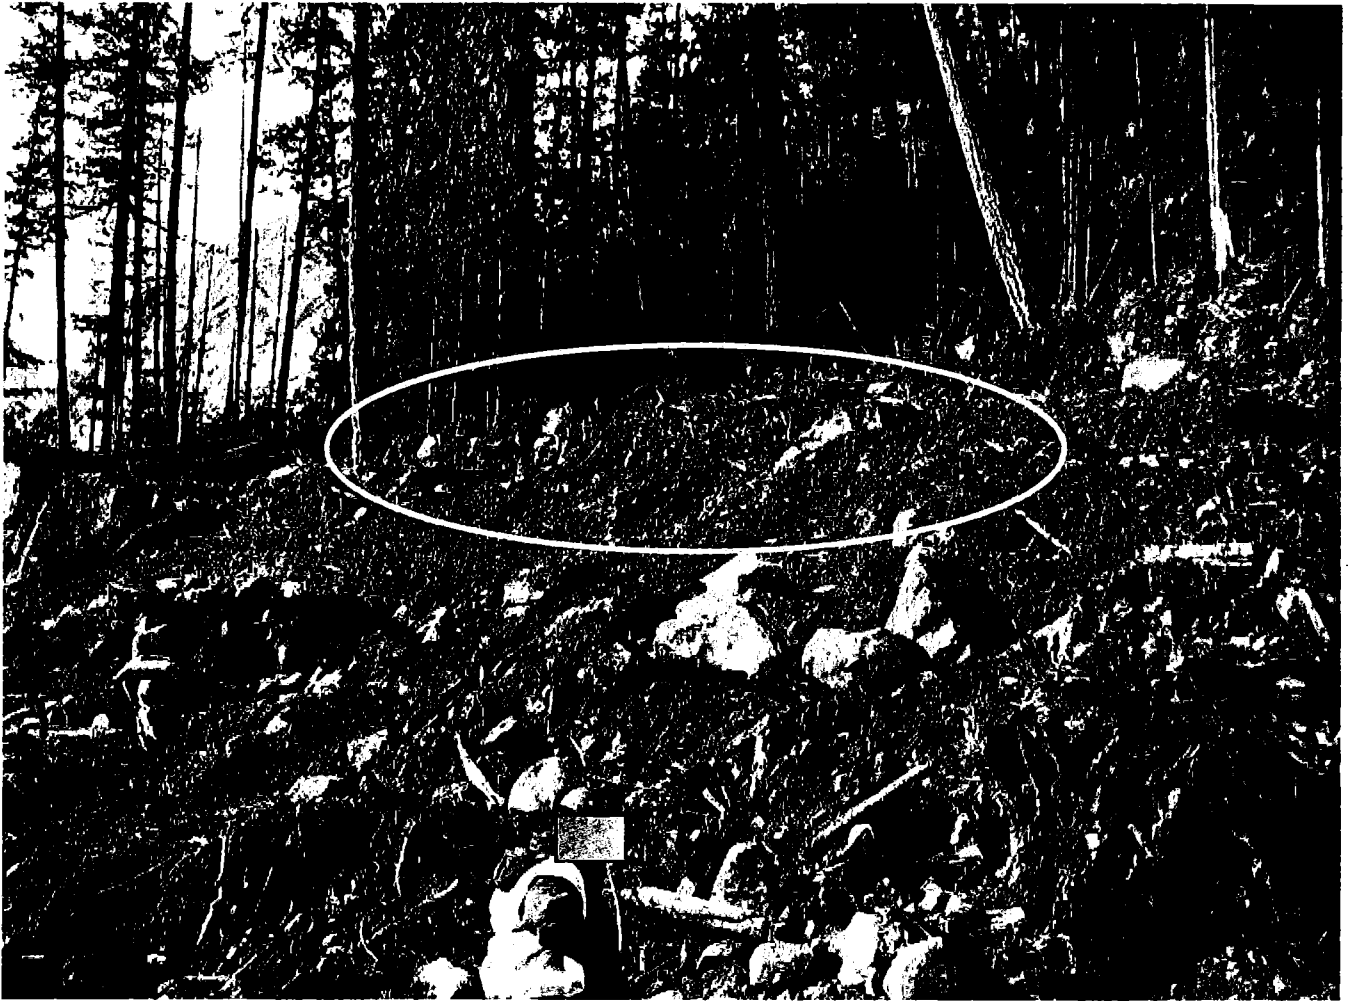
Figure 7. Rough area adjacent to previously machine-scaled ground.

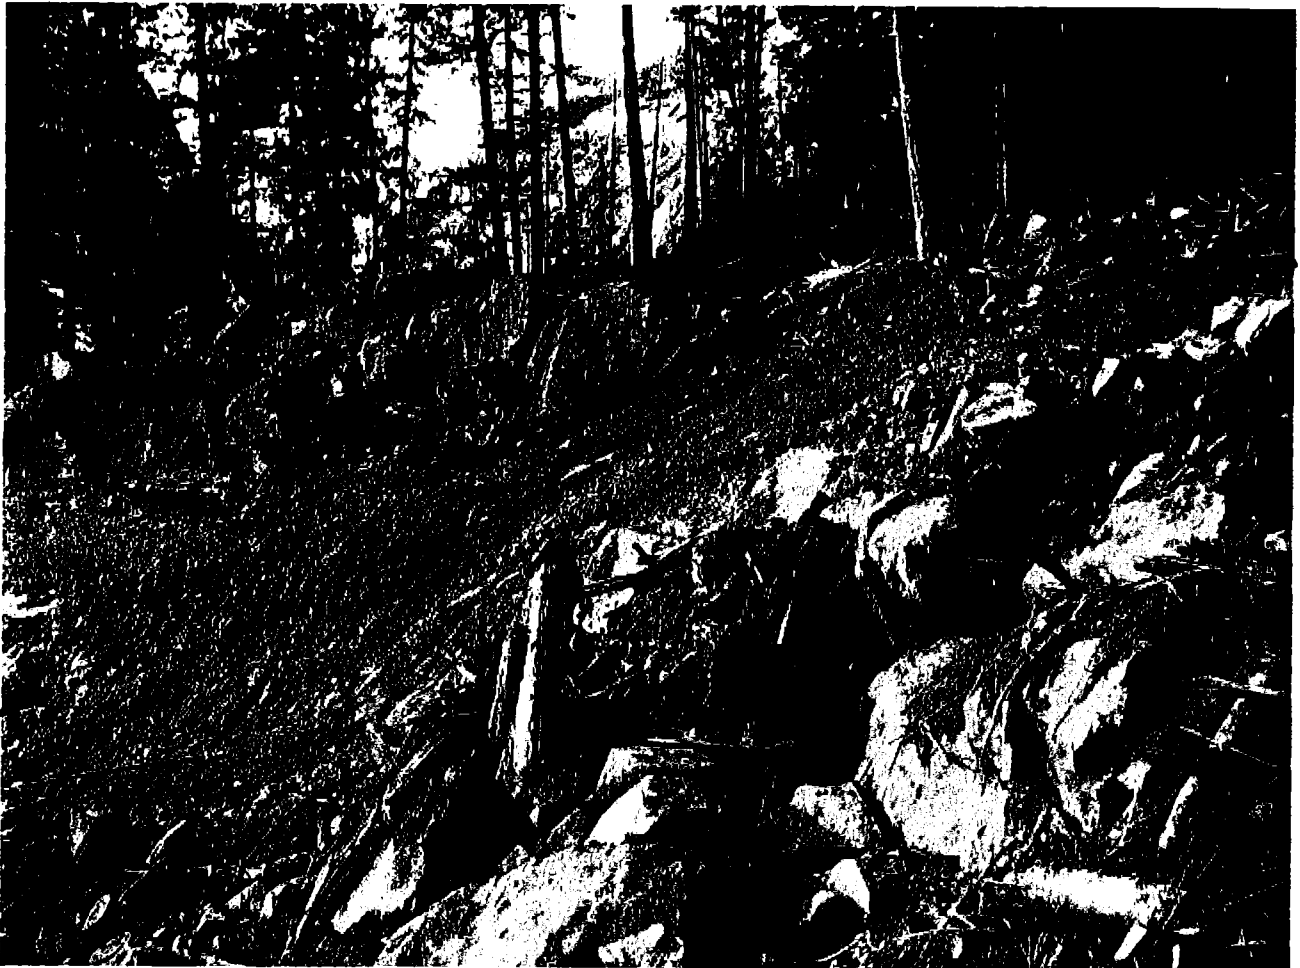
Figure 8. Previously machine-scaled area. The dotted line indicates the rock's path that the Excavator Operator described.

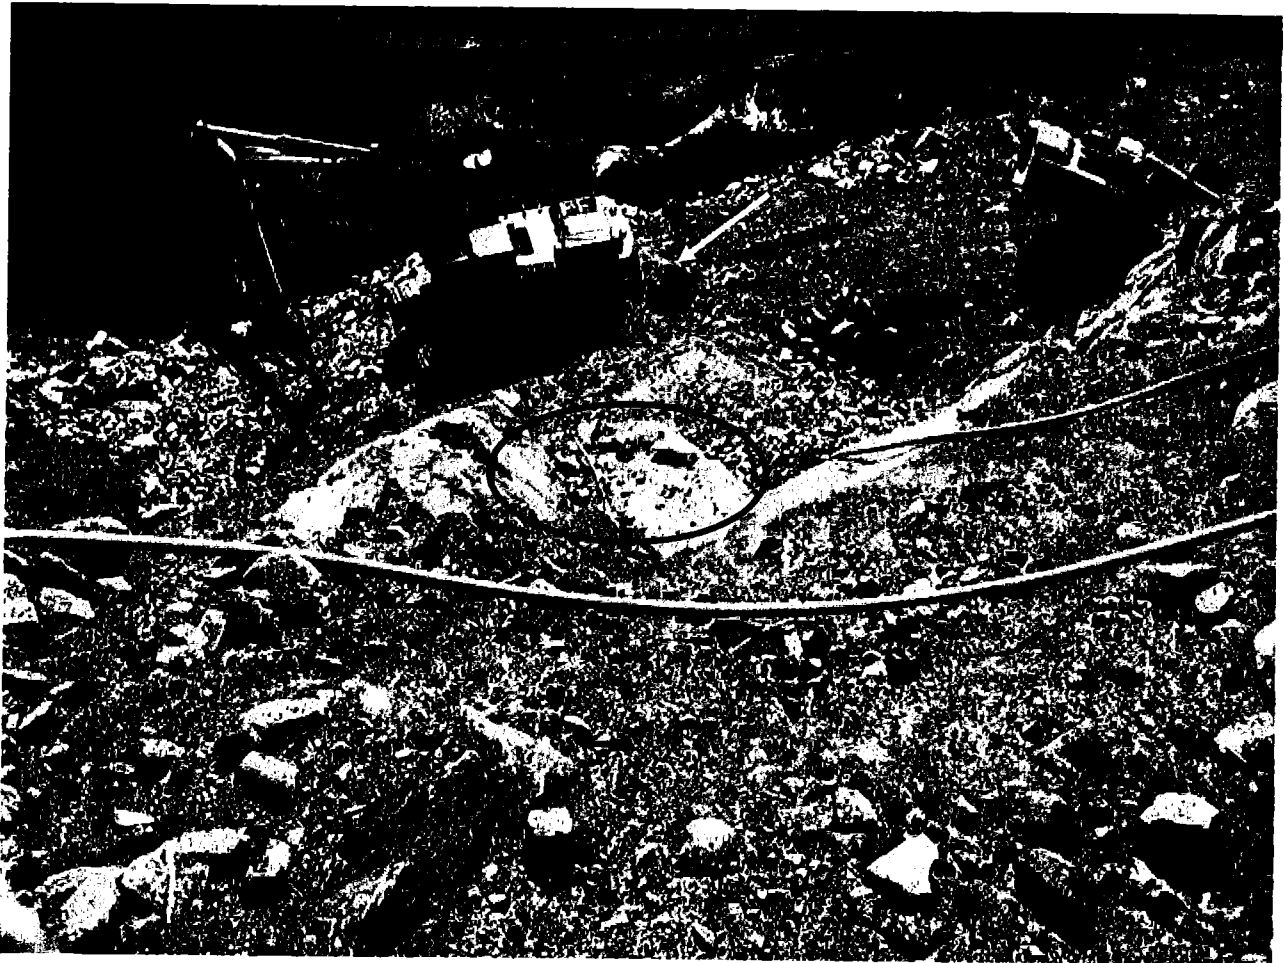
The rock partially fragmented after striking Scaler 1 and the boulder he had been drilling, but a large portion of the rock continued to come directly toward the hoe drill. The Blaster looked toward the area and saw the Hoe Drill Operator rapidly move from near the hoe drill's left track to escape being struck by the rock by taking shelter beside the rock face. Scaler 2 remained in the cab of the hoe drill. The rock struck the track of the hoe drill and split apart into several pieces. Some of the rock's fragments remained beside the hoe drill's left track and the rock face, and a large portion landed behind the rear of the hoe drill (see Figures 10 and 11).

Figure 10. Fatality scene indicated by the circled area. The rock split apart during the incident. Some of the rock's fragments remained on the boulder. The arrow points to one of the rock's fragments that landed behind the hoe drill.

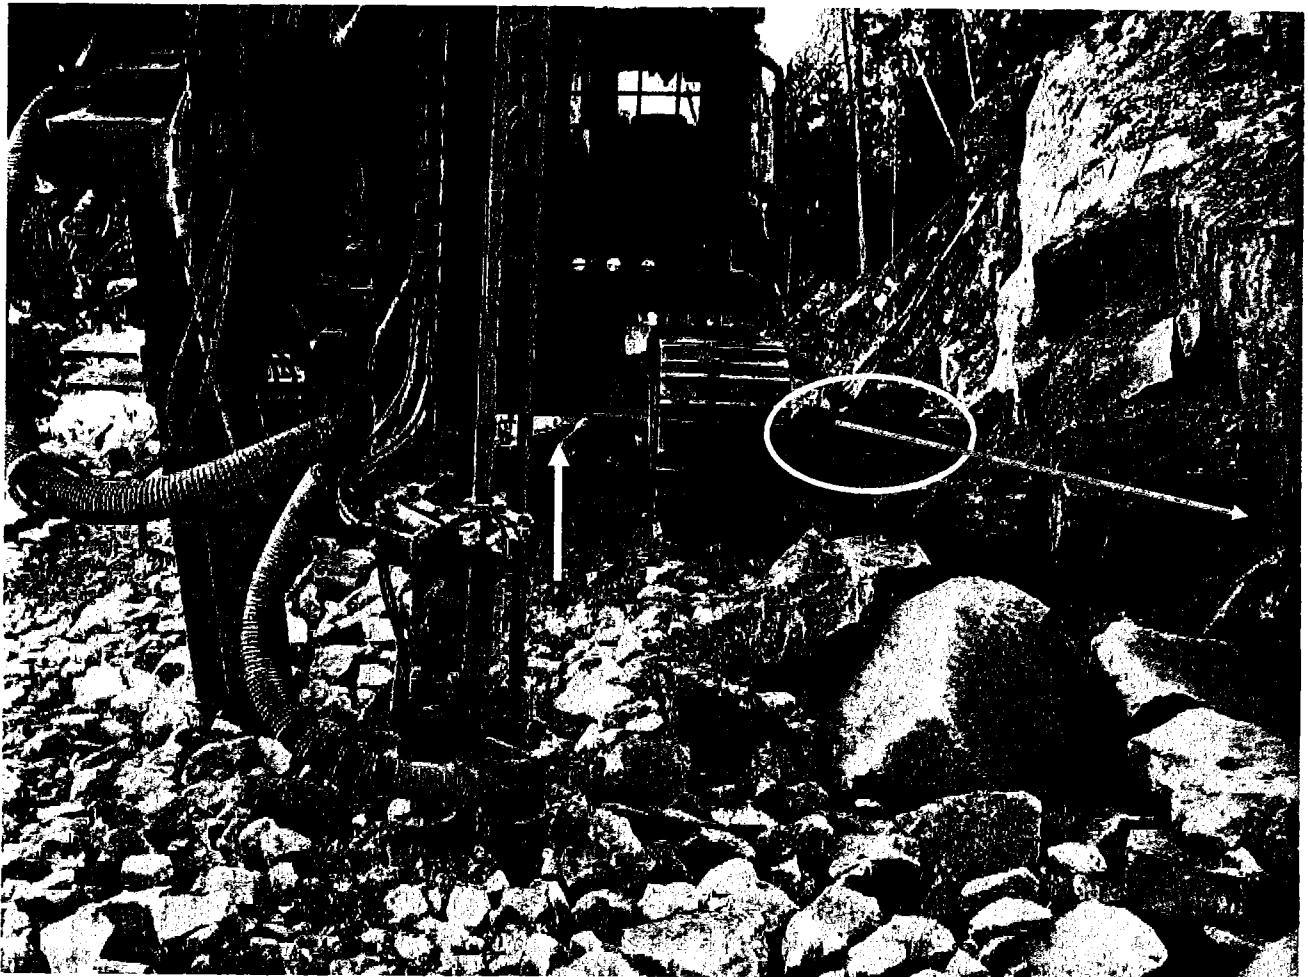
Figure 11. Rock fragments between the left track of hoe drill and the rock face are circled. The blue arrow points to where the Hoe Drill Operator moved to take shelter from the rolling rock. The yellow upward arrow points to the rock fragment behind the hoe drill.

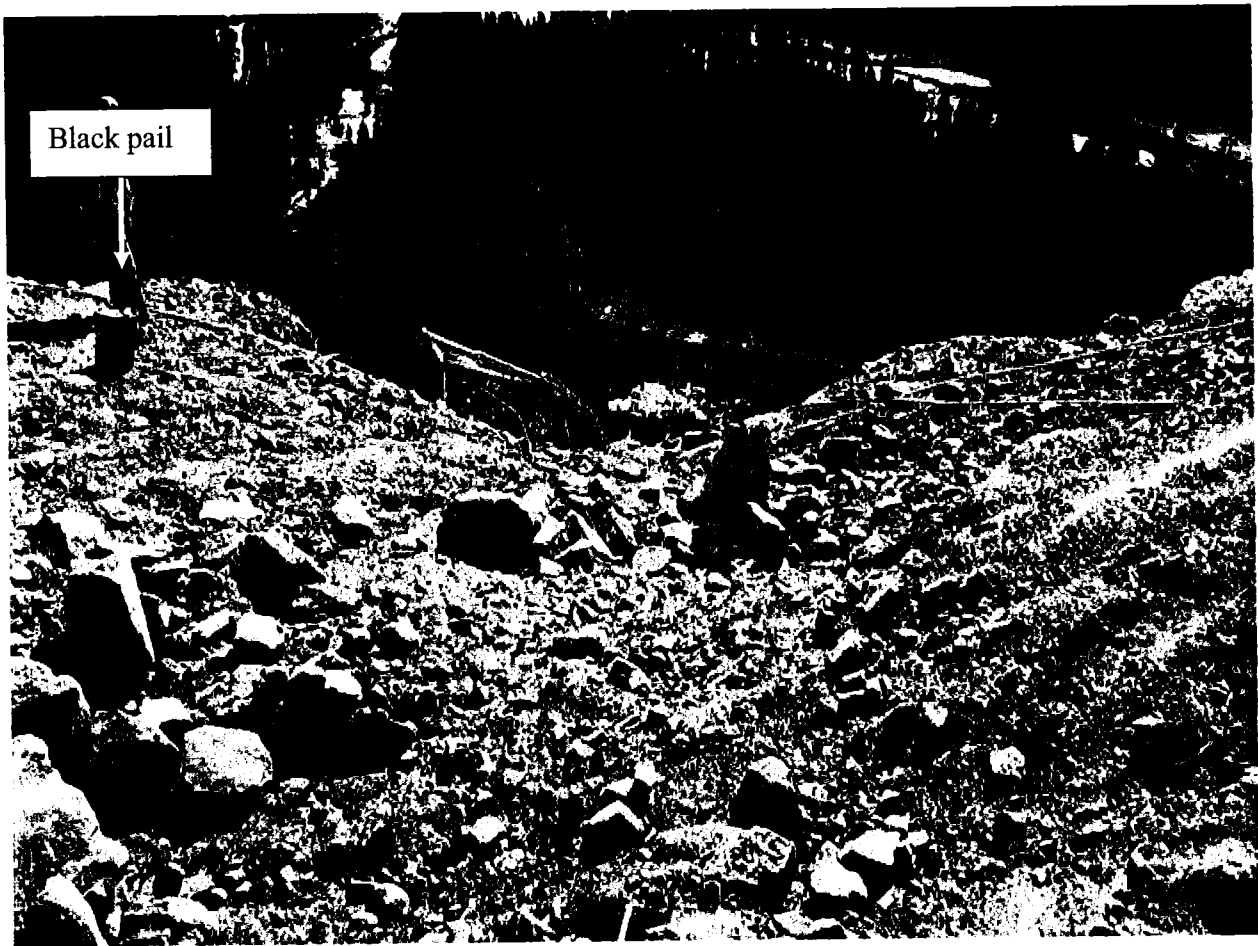
Above Bench 4, there was a significant trough-like depression in the ground (see Figure 12). Persons interviewed were aware of the presence of this trough and further understood that material that rolled in the area and entered the trough would likely roll farther onto Bench 4. The terrain above the crest of the hill sloped to varying degrees in different locations; Kiewit engineering personnel estimated that the area where the rock was seen rolling had a slope of 30 to 35 percent.

Figure 12. Trough above Bench 4. The rock rolled down the trough and beside the black pail. The upper components of the hoe drill (still where it was parked when the fatality occurred) are visible near the centre of the photograph.

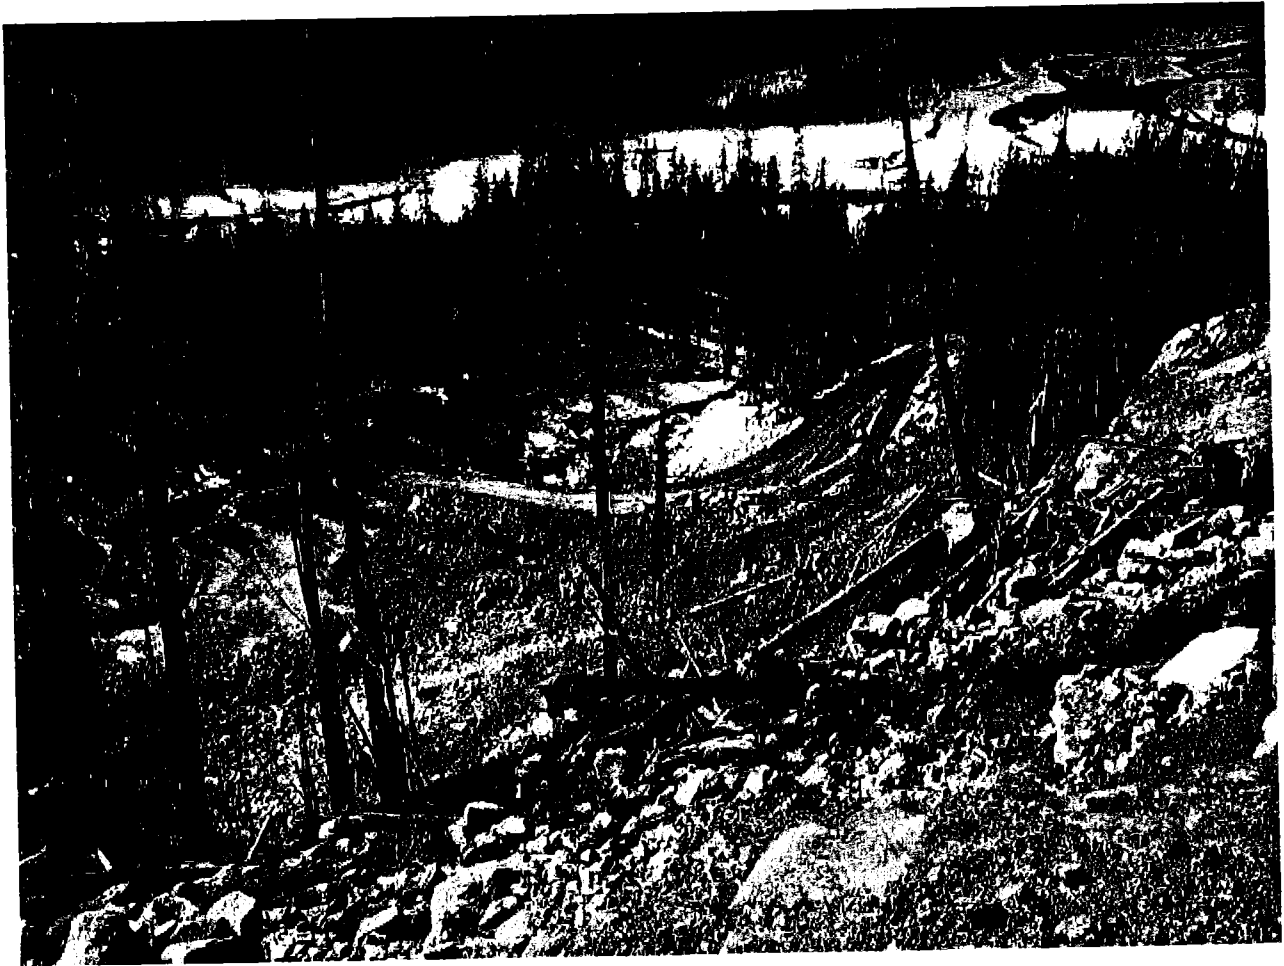
Below the access road to Bench 4, and above the main access road to the site, there were loose rocks, forest debris, and logs (see Figure 15). These materials presented falling material hazards to persons travelling on roads or working below them.

Figure 15. Unstable rock, forest debris, and logs below the Bench 4 access road and above the main access road.
