28 May 2012

Subject: Toba Montrose Fatal Scaling Incident – February 22, 2009

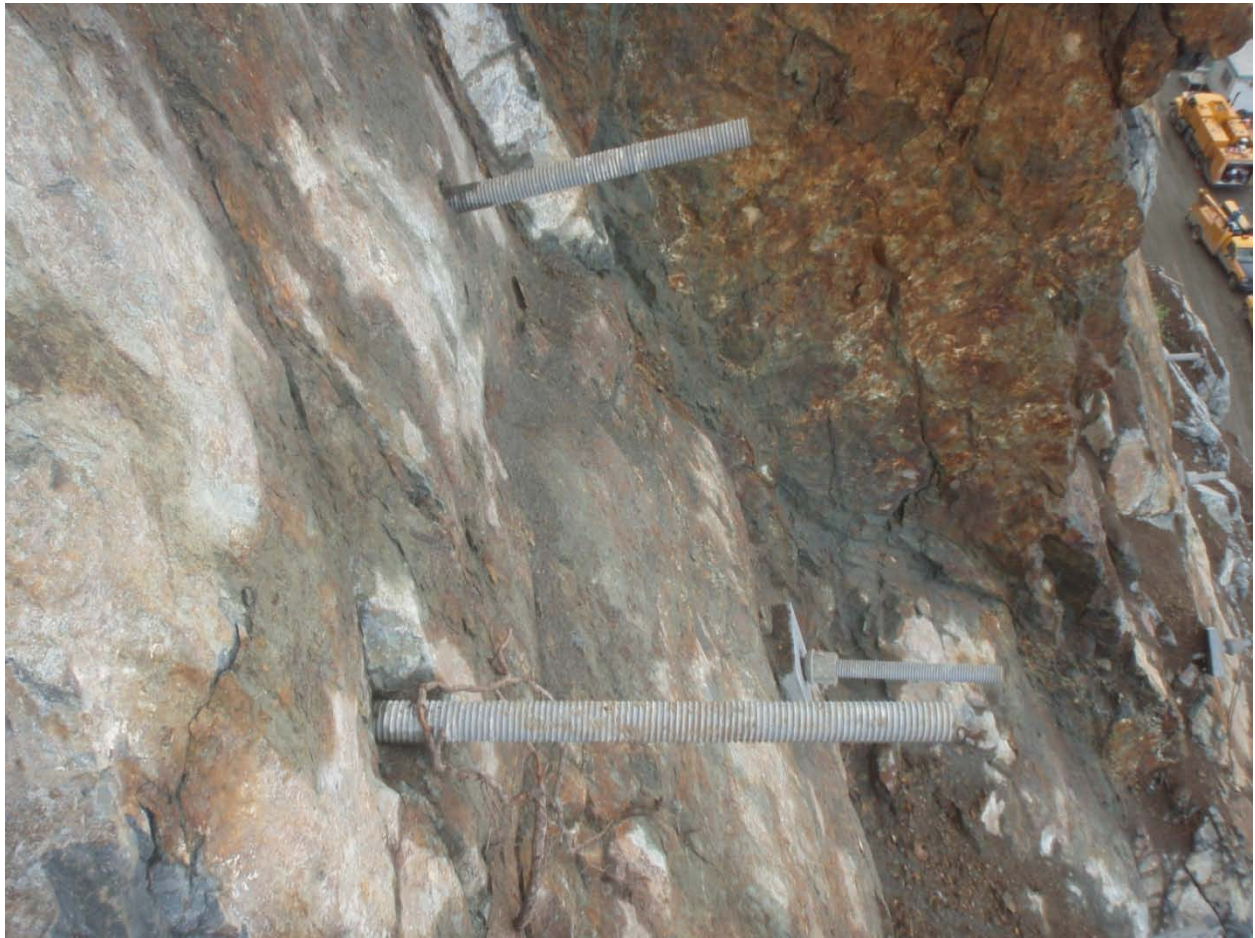
1. Over 23 of the rock bolts were not fully encapsulated with grout to ensure proper bonding.
2. The majority of rock bolts did not have nuts or plates on the anchors
3. Nearly all the anchors were not tensioned to apply tension on the slope to prevent movement of the rock
4. A majority of the anchors were not even grouted.

**Figure 1. Anchors with no plates or grout on Cut 9, Segment 1. These anchors are to be tensioned rock bolts.**

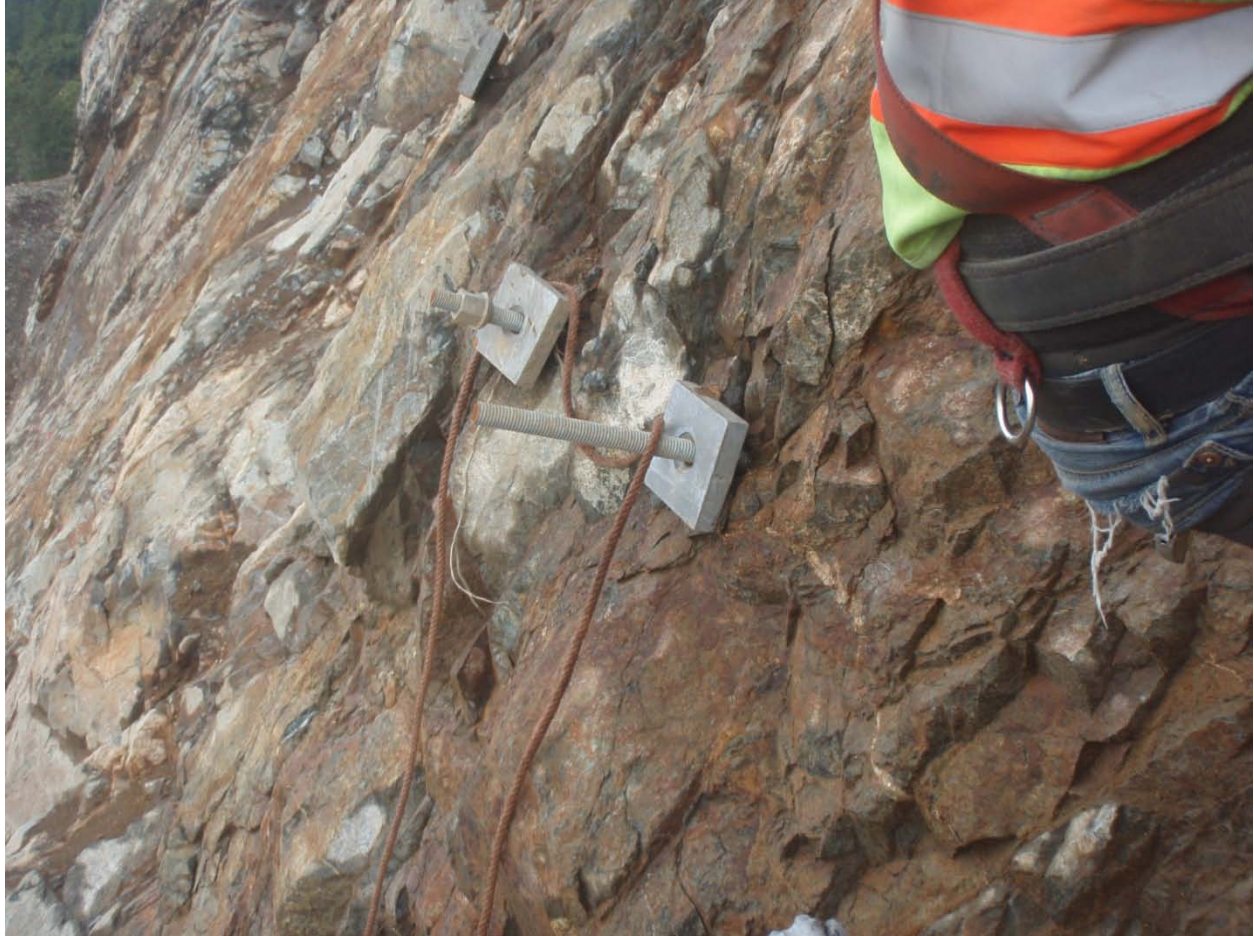
**Figure 2. Anchors on Cut 9/Segment 1. Anchors not properly installed. Limited or no grout and anchors not tensioned.**

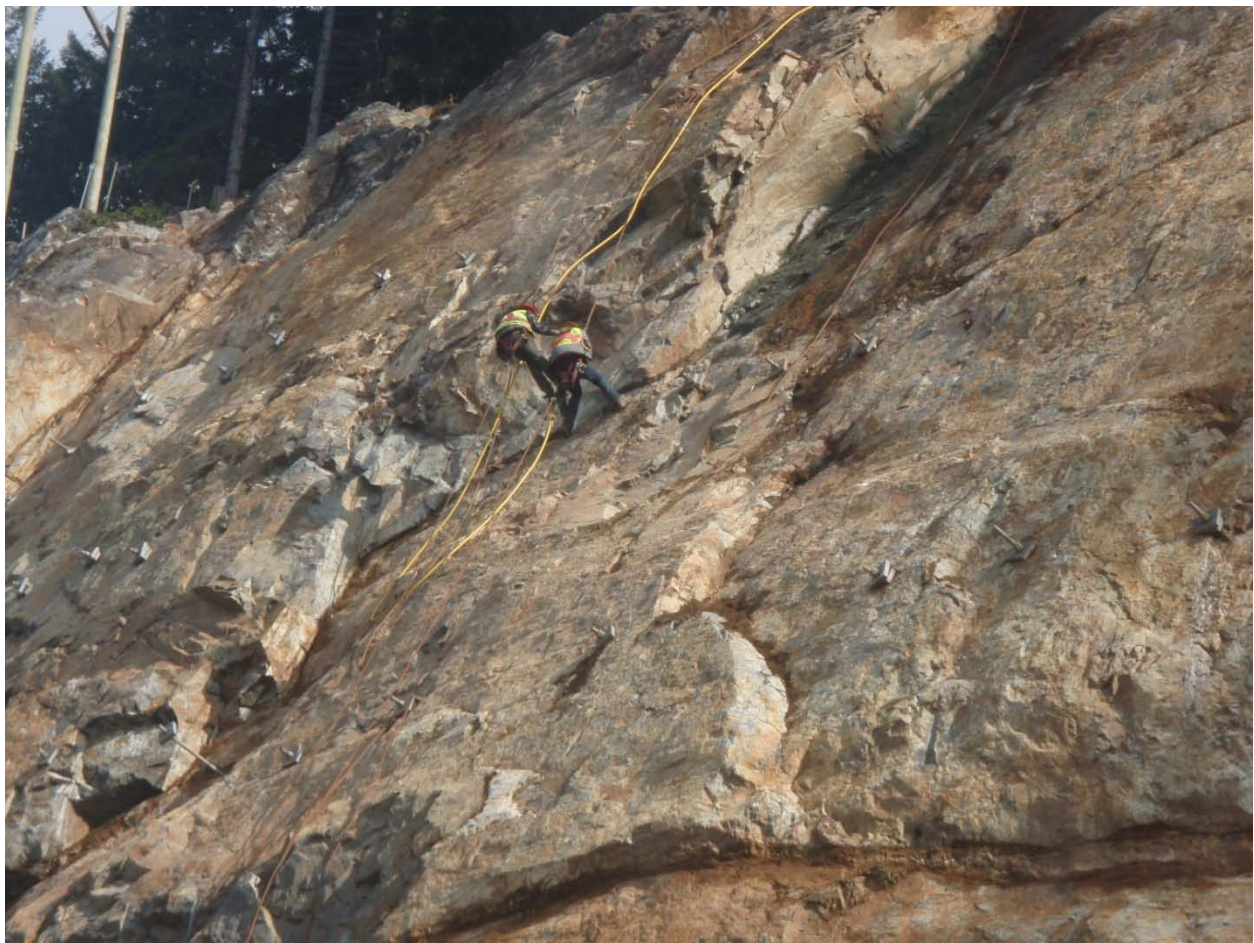
After 2 weeks on the site, we had Kiewit personnel enter the site above the cut without prior approval from myself. I remind you that I had total control of the site. The personnel entered the site, ignoring the posted safety signs that indicated to radio the scaling supervisor prior to entering the site. The personnel walked across the top of the cut, above our scalers drilling 100 feet below on the rock face. Two drillers were drilling and installing dowels in preparation for shotcrete. Each scaler took turns operating the 60 lb rock drill while the other spotted for potential rock fall. The three Kiewit personnel past over the top of the scalers and knocked a 1 foot diameter boulder down from the flat crest (brow) above.

The rock descended the face of the cut, approximately 100 feet. The spotter spotted the rock descending the cut. He grabbed a hold of the scaler drilling, but due to the speed of the decent of the boulder, the boulder impacted the scaler drilling, in the forehead. The scaler received a laceration above the left eye. He was able to move out of the way enough to prevent a direct impact. The scalers descended the cut and I was contacted on the radio. I got to site to find the injured scaler going after the Kiewit personnel that unlawfully entered the site. The three Kiewit personnel left the site and never asked how the scaler was. In addition, we never knew who they were.

**Figure 3. Cut 9/Segment 1. Photo taken one hour prior to the scalers being struck by rock.**
