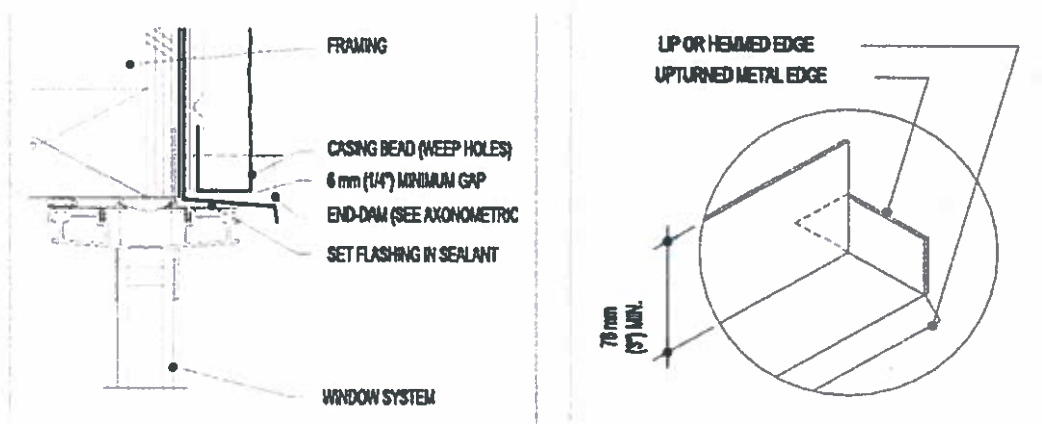
Fig. 44: End dam for window head. Note also that the flashing drip edge extends far away from the wall.

An illustration of a flashing, which is inserted upward behind the cladding and an end dam detail that complies with the Alberta Building Code is shown in figure 44.

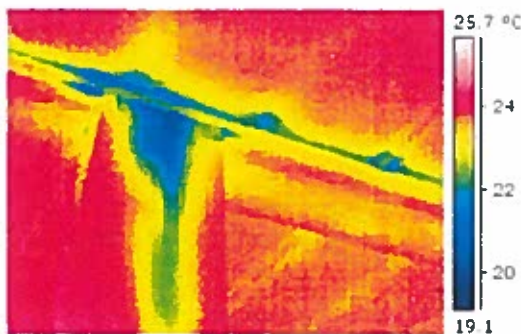
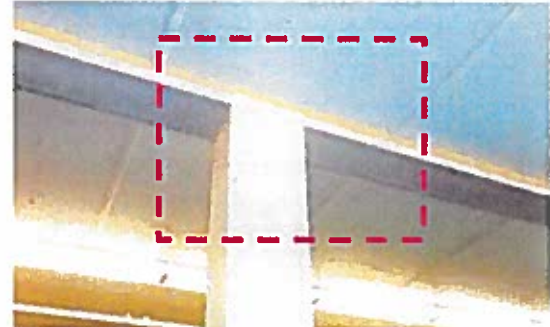
Our thermographic scans also revealed many cold signatures along the junction beams where the modules are spliced together (figures 51 and 52). These cold signatures may indicate the presence of moisture. On the roof, these junctions are difficult to seal properly with roofing membrane. The membranes are often folded and thus gaps are created, which are prone to leaks (figures 53 and 54). A particularly difficult area to create a watertight roofing membrane is at the junctions (figures 55 and 56). Furthermore, differential movements between the modules from thermal expansion and contraction, as well as settlement and wind forces cause shifting at the junction that could tear the roof membrane.

Fig. 52: Cold signature migrating down this column in the exercise room.

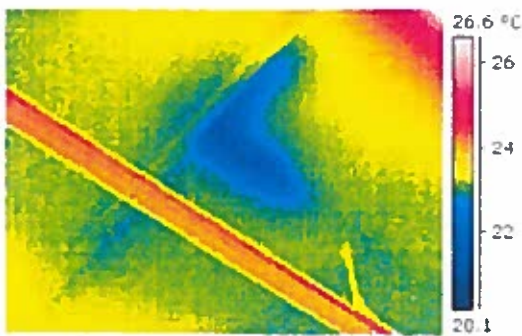
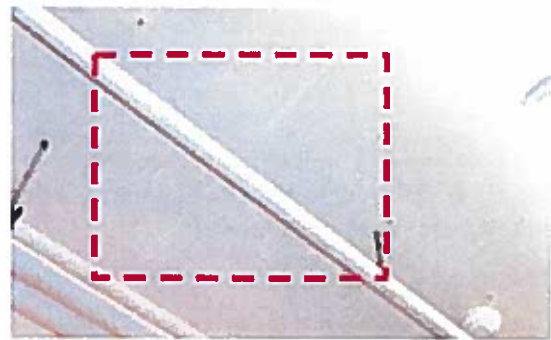
These penetrations may be the cause of cold signatures on the ceiling of the kitchen and other areas (figures 59 and 60).

Fig. 59: Thermographic scan of the kitchen ceiling shows cold spots.

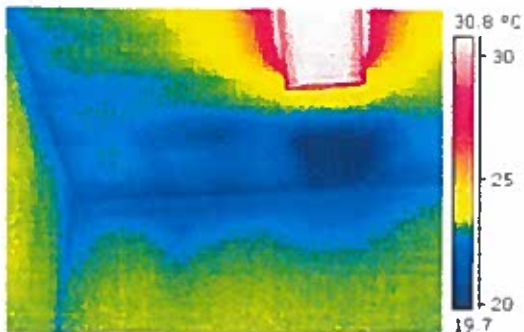
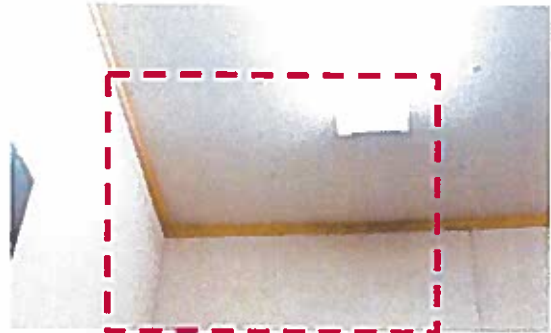
The security office adjacent to the front office is also showing signs of moisture in the ceiling (figure 84). A large cold spot is noted in another corner of this office (figure 85). The adjacent conference room also has evidence of cold spots (figure 86). As mentioned above, some of the cold signatures have been verified with a moisture meter. However, several areas are also moist to touch and others are beginning to show signs of water staining.

Fig. 85: Another cold signature in the corner of the security office

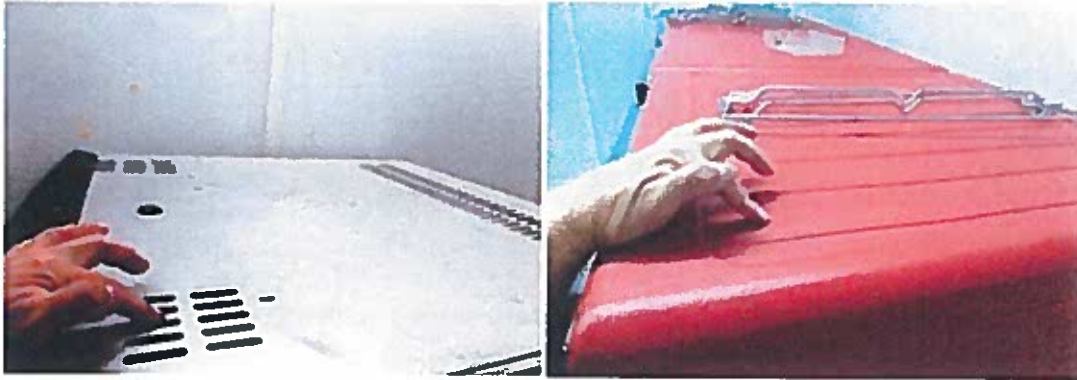
Dust is being drawn into the building, including into the kitchen, thus compromising hygiene, which can affect food safety. There is dust accumulating on the top of various equipment (figures 100 and 101).

Figs. 100 & 101: Dust on top of kitchen equipment.

Some of the dust is clearly visible and can be wiped off (figure 102). The top of walls and shelves as well as the contents are covered with a layer of dust (figure 103). Regular maintenance can remove the dust that is easily accessible, but hard to reach areas are less frequently cleaned.

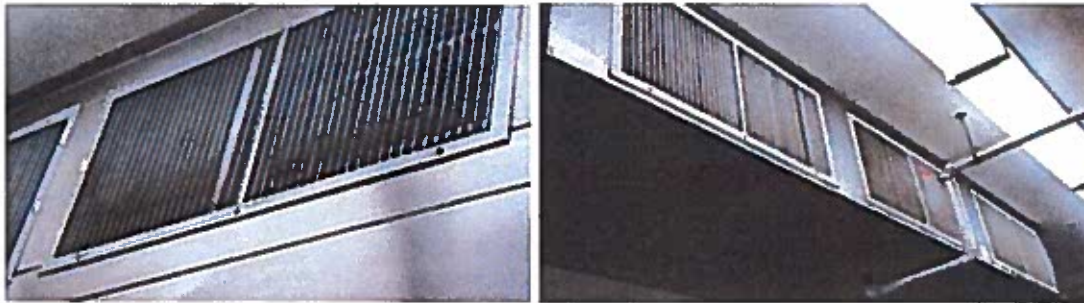
The MUA supply grilles in the kitchen are visibly dirty (figures 104 and 105).

Figs. 104 and 105: Dirty air supply grilles in the Kitchen.

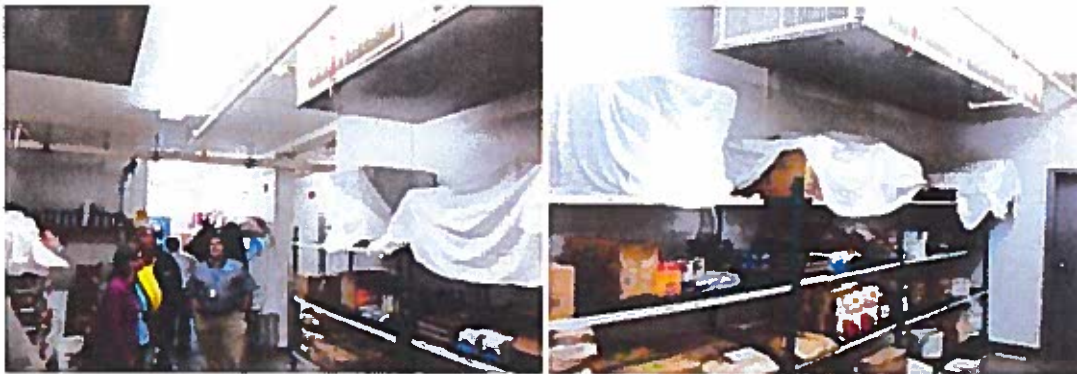
At Conklin Lodge, the kitchen staff has covered much of the stored goods with white cloth to keep the dust and insects off the stored food (figures 106, 107, 108 and 109).

Figs. 106 & 107: Kitchen staff cover packages of food.

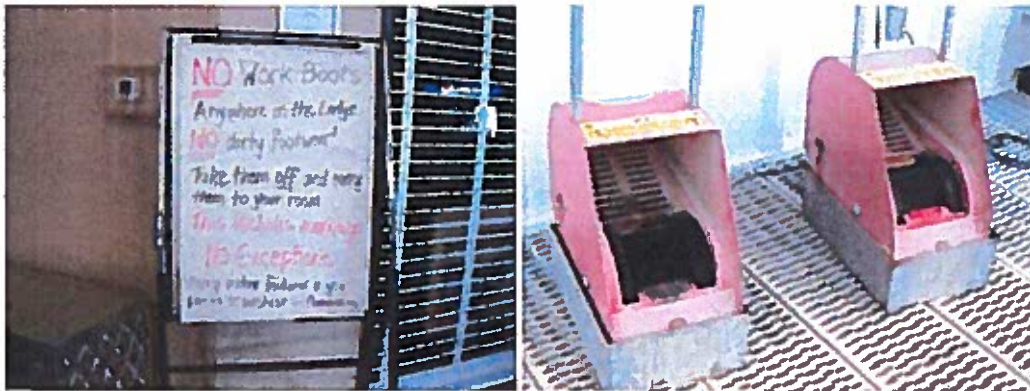
Fig. 112: No work boots posted sign.

Fig. 113: Boot washers located outside the door for use before entry.

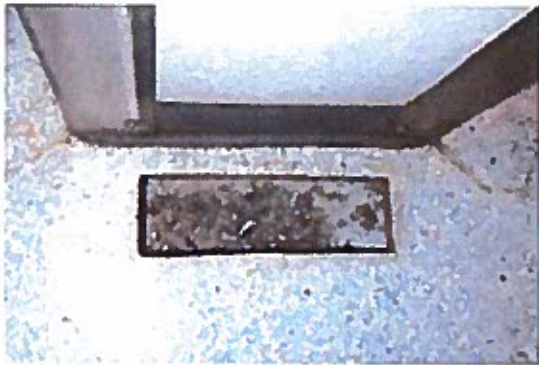
There were considerable amounts of debris, grease, dust, food particles, etc. in the kitchen ductwork (figures 143 and 144). The debris is unsanitary as microorganism can grow inside these ducts (figure 145). Insects and rodents will find ample food in these ducts and may be nesting in them. Periodic maintenance is required to clean these ducts, but floor ducts are notorious for accumulating spills and debris. These air registers should be positioned on walls instead of the floor.

Fig. 143: Very dirty ducting inside the floor register.

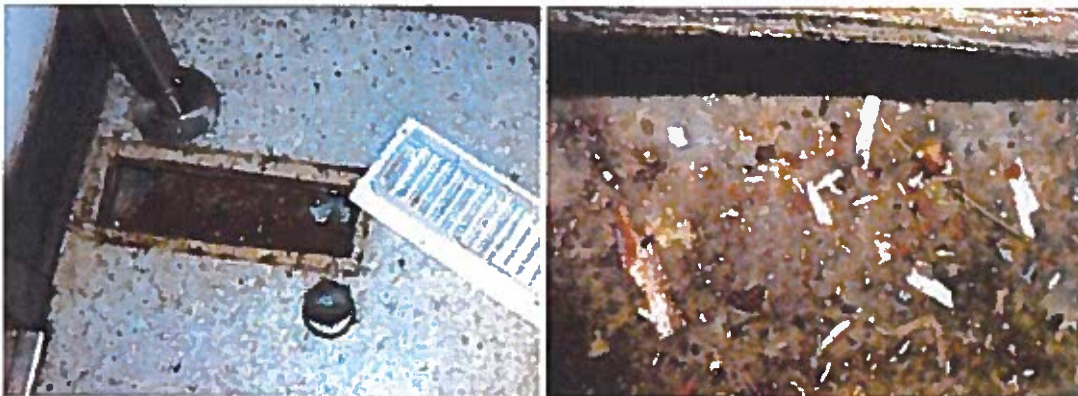
Fig. 144: Dirty ducting underneath this floor register.

Fig. 145: Close-up of the debris in the ducting.
