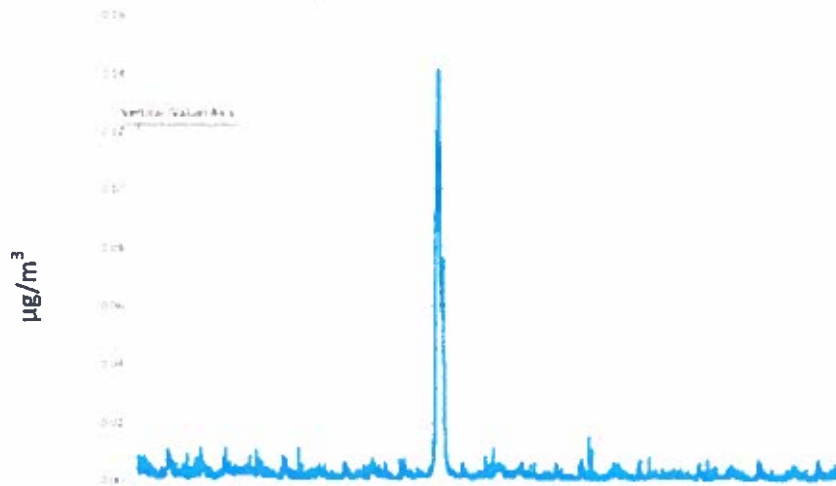
Fig. 168: Airborne Particulates in Lobby Reception

All airborne particulate concentrations PM2.5 were well under the guideline of being less than outdoor levels, which is recommended to be less than  $30\mu\text{m}/\text{m}^3$ . The highest level measured was in the bag-up room where concentrations rose to  $0.16\mu\text{m}/\text{m}^3$  for a short period of time. The lobby also experienced a spike in PM2.5 concentrations at the same time.

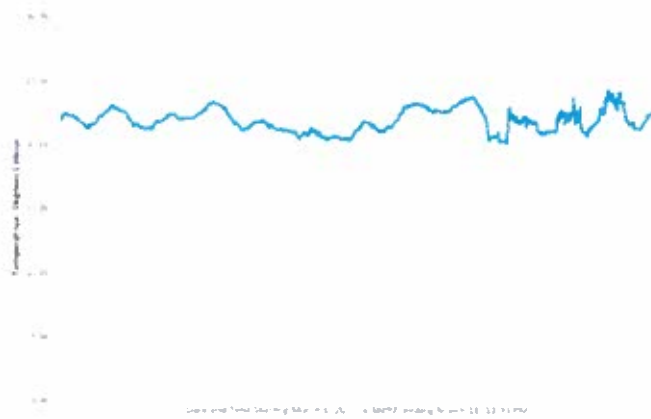
Fig. 176: Lobby Reception Temperature

Temperature measurements at four indoor locations were generally 20-24°C. The bag-up room tended to be a little warmer for the first ten days and then dropped (figure 175). Two major fluctuations happened in the kitchen about the same time. Housekeeping also experienced a fluctuation.

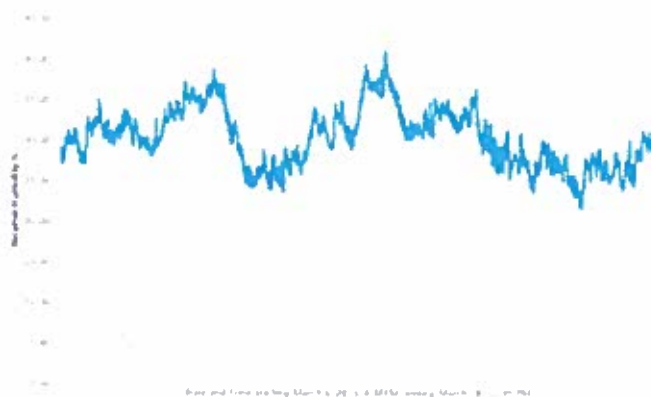
Fig. 180: Relative Humidity Lobby Reception

The relative humidity varied between 22-40%RH in the lobby reception; 20-50%RH in the bag-up room; 12-35%RH in the kitchen; and 10-25%RH in housekeeping.

The 10%RH in housekeeping is somewhat low, but the other areas are within the guidelines of 20-30%RH in winter in Alberta.
