MEMORANDUM

TO: John Dhaliwal, Review Officer
FROM: James A. McJannet, Barrister & Solicitor, Investigations
Legal Officer
DATE: January 6, 2012
SUBJECT: Request for Review - RFR #R0130850
RFS 201100256
Administrative Penalty IR 2011110870029
Applicant/Firm: Peter Kiewit Infrastructure Co.
Firm No.: 76110

Officer Barbara Deschenes' Response to Employer's Submission

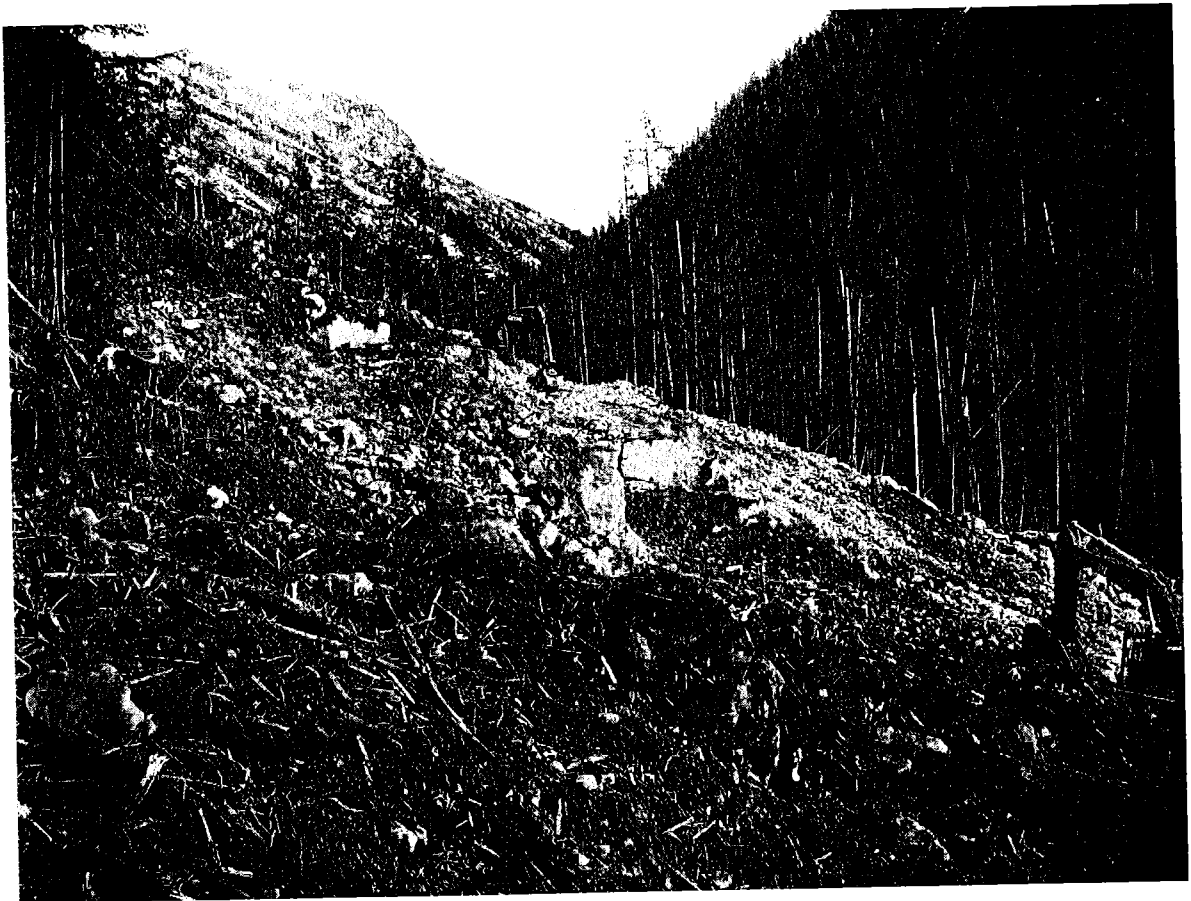
There can be no question the hazards posed by the large amounts of loose material on the upslope portion of the site were obvious and the Employer's efforts to address the issue were wholly inadequate, despite the incident only one day before where a boulder rolled downhill to an area populated by a work crew. This was acknowledged to me by the Employer's Project Manager, Chris Dandurand:
